## **Lockport-Batavia Line #112 Rebuild Project**

### **EM&CP Update**

### **Replacement Appendix G (SWPPP)**

*(Revised January 2026; Replaces Version Filed June 2025)*

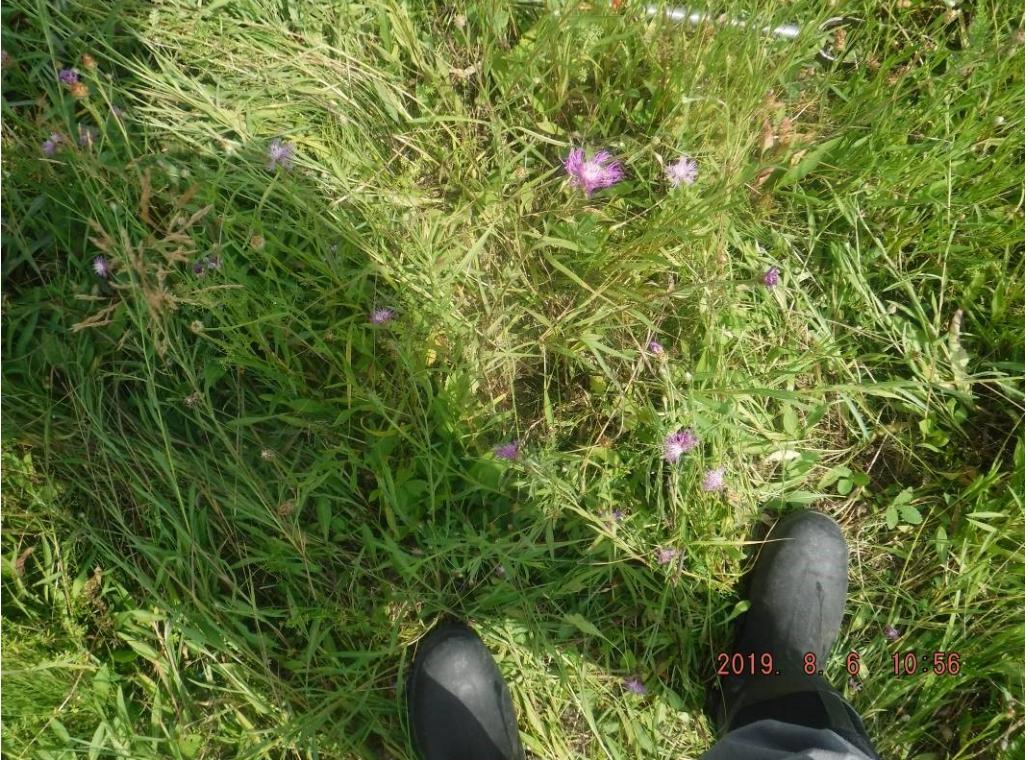
<b>Photo No. 1</b>

Facing North

<b>Description:</b>	
<p>Data Point 001 Data Point for upland/dryland adjacent to Wetland 001.</p>

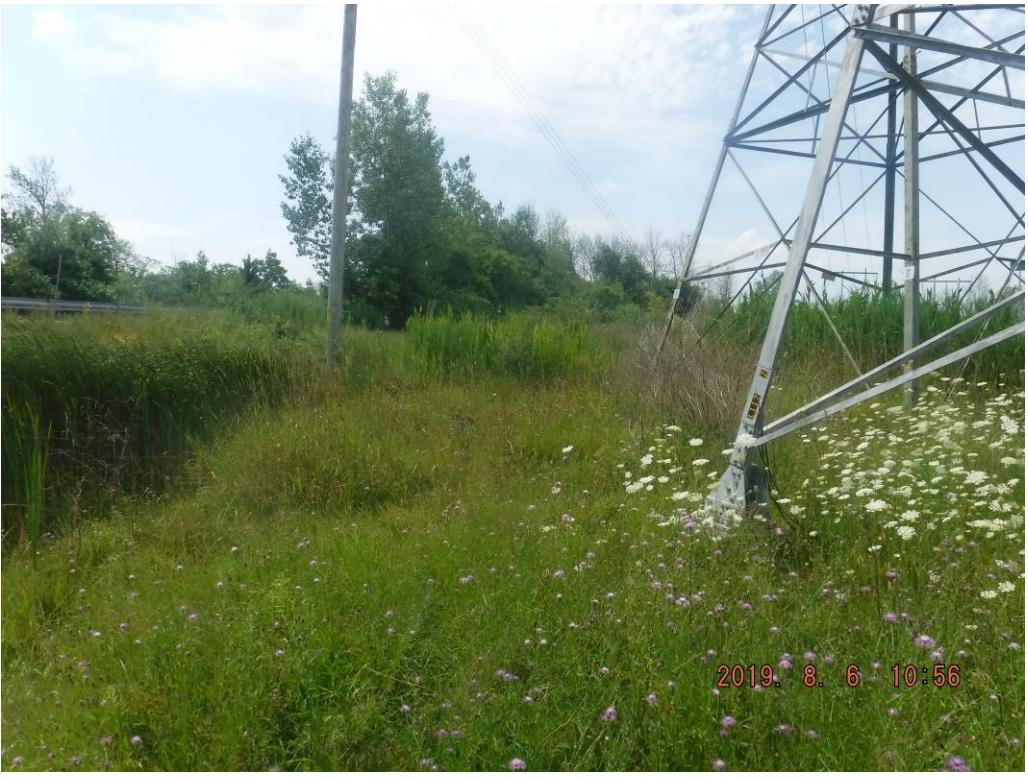
<b>Photo No. 2</b>

Facing South

<b>Description:</b>	
<p>Data Point 001 Overview of upland/dryland adjacent to Wetland 001.</p>

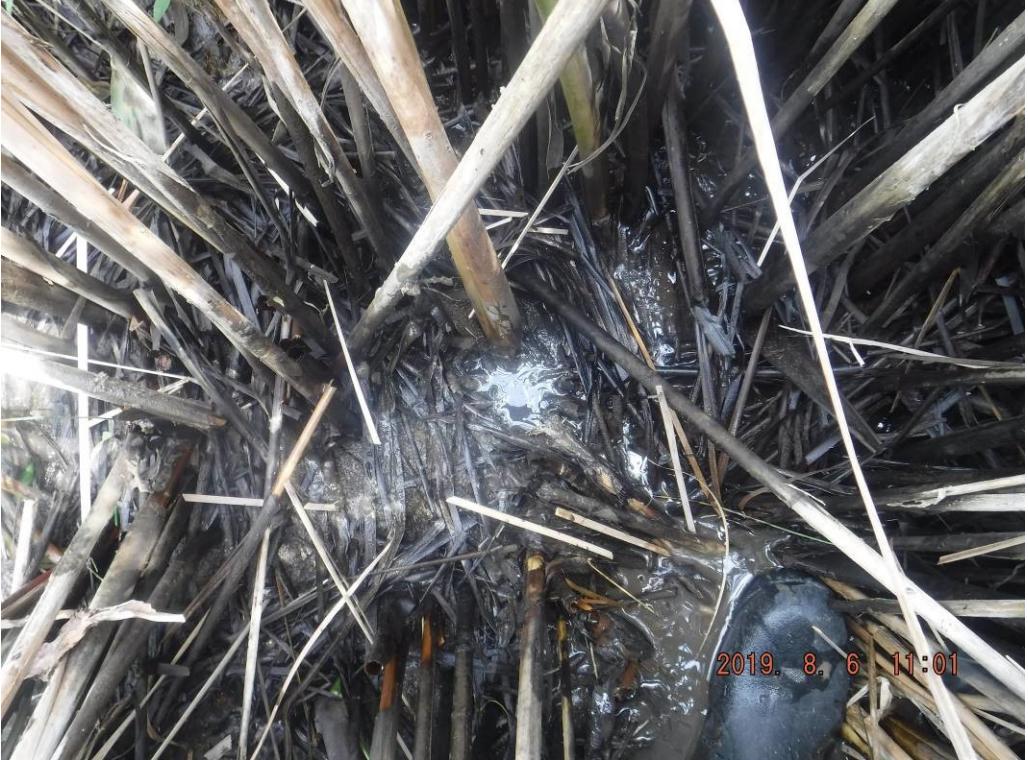
<b>Photo No. 3</b>

<b>Description:</b> Data Point 002 PEM Data Point for Wetland 001.

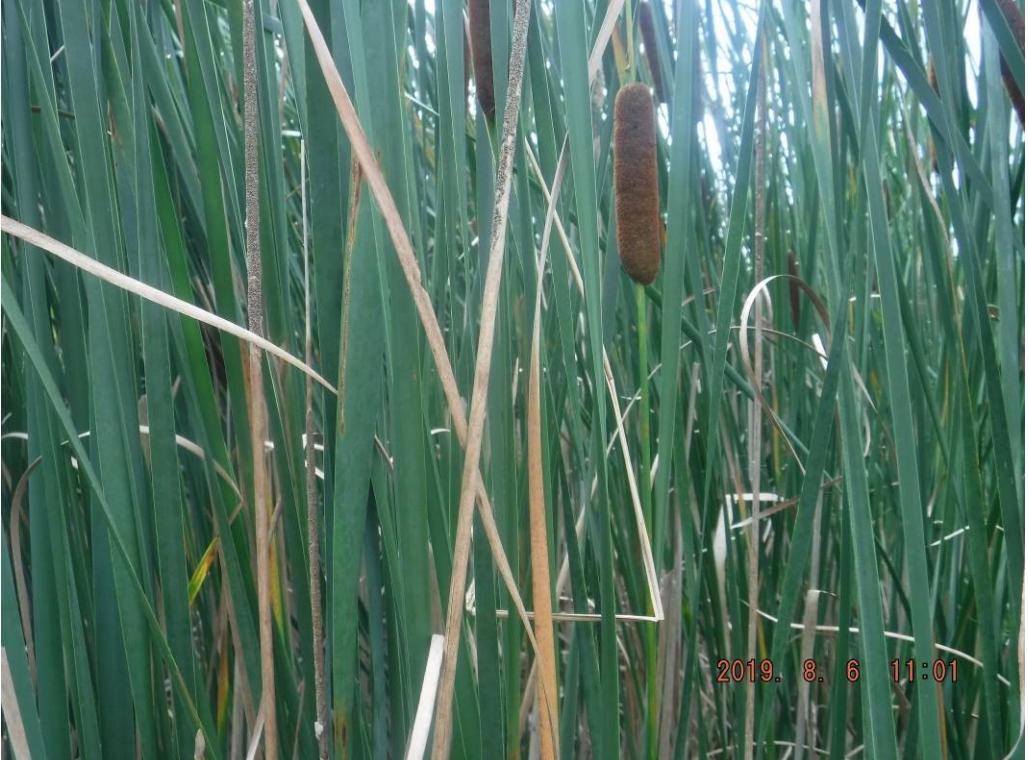
<b>Photo No. 4</b>

<b>Description:</b> Data Point 002 Overview of PEM Wetland 001.

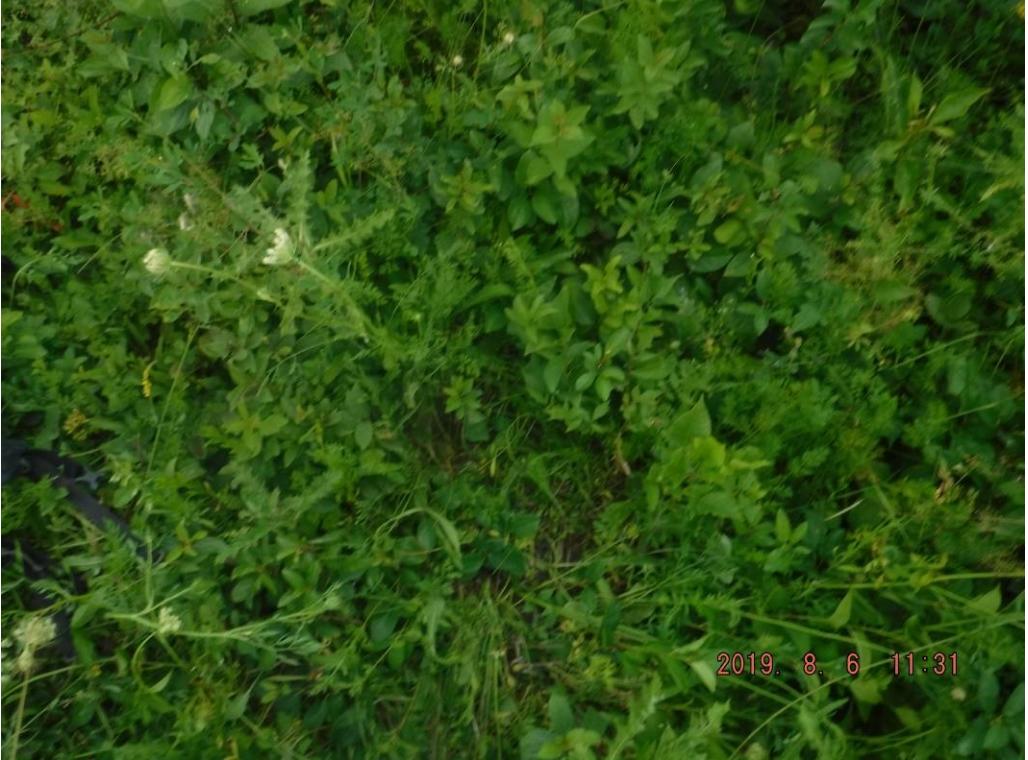
<b>Photo No. 5</b>

Facing North

<b>Description:</b> Data Point 003  Data Point for upland/dryland adjacent to Wetland 002.
---

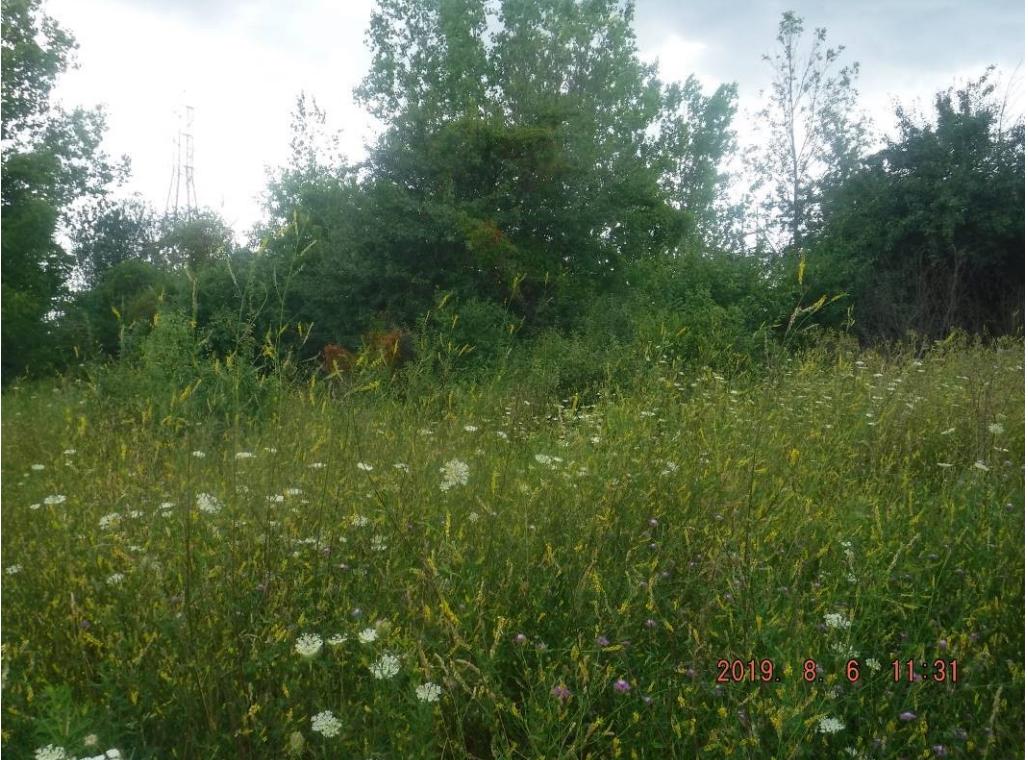
<b>Photo No. 6</b>

Facing North

<b>Description:</b> Data Point 003  Overview of upland/dryland adjacent to Wetland 002.
--

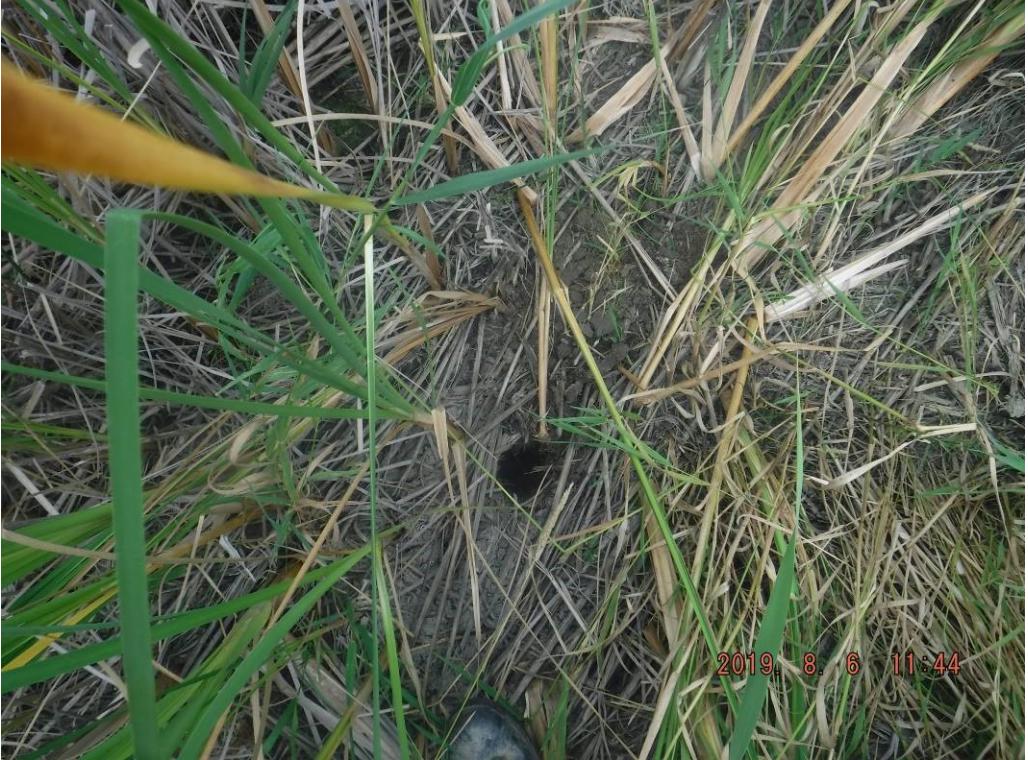
<b>Photo No. 7</b>

<p>2019 8 6 11:44</p>
<b>Facing North</b>  <b>Description:</b> Data Point 004 PEM Data Point for Wetland 002.

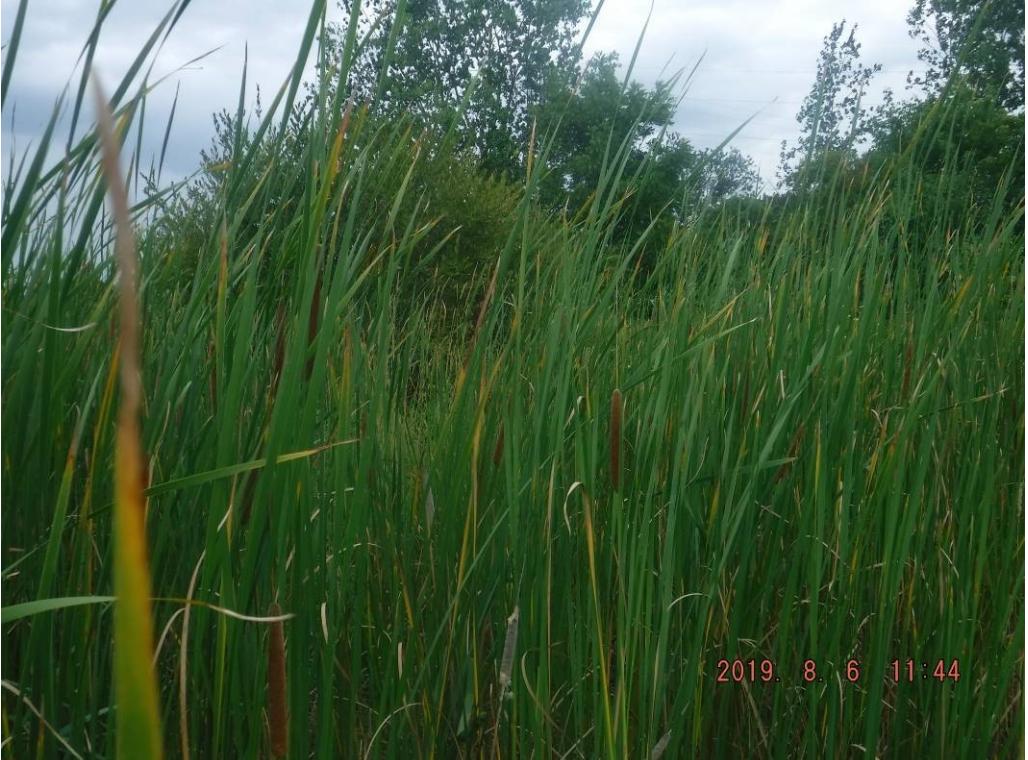
<b>Photo No. 8</b>

<p>2019 8 6 11:44</p>
<b>Facing North</b>  <b>Description:</b> Data Point 004 Overview of PEM Wetland 002.

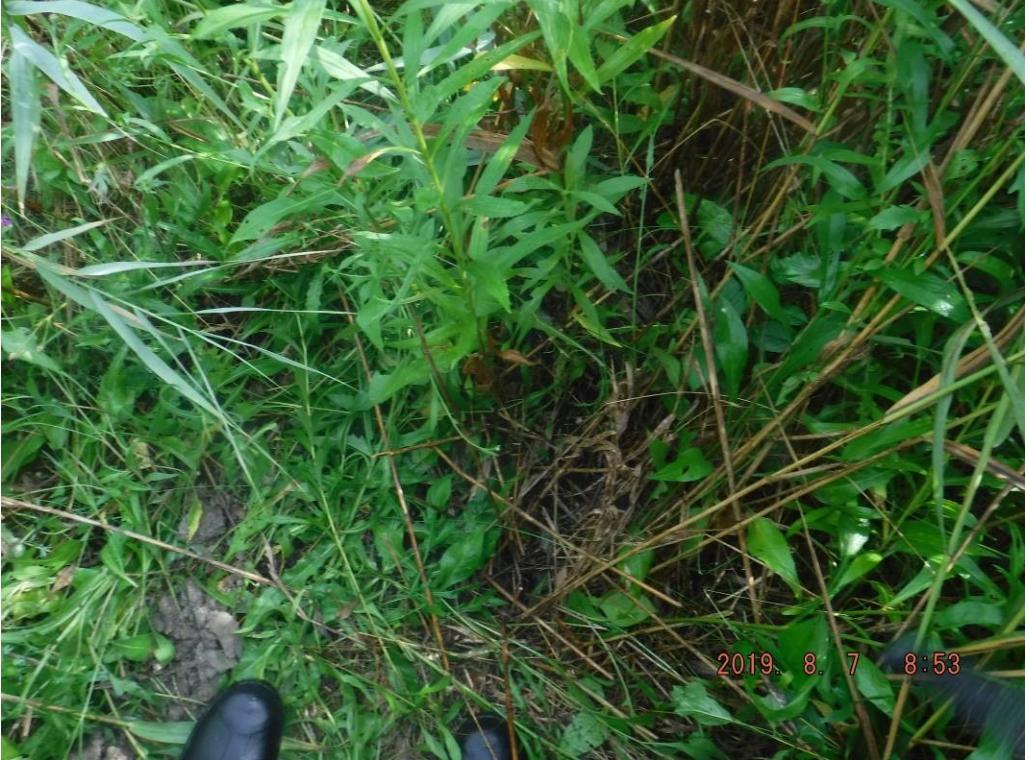
<b>Photo No. 9</b>

<b>Description:</b> Data Point 006 PEM Data Point for Wetland 003.

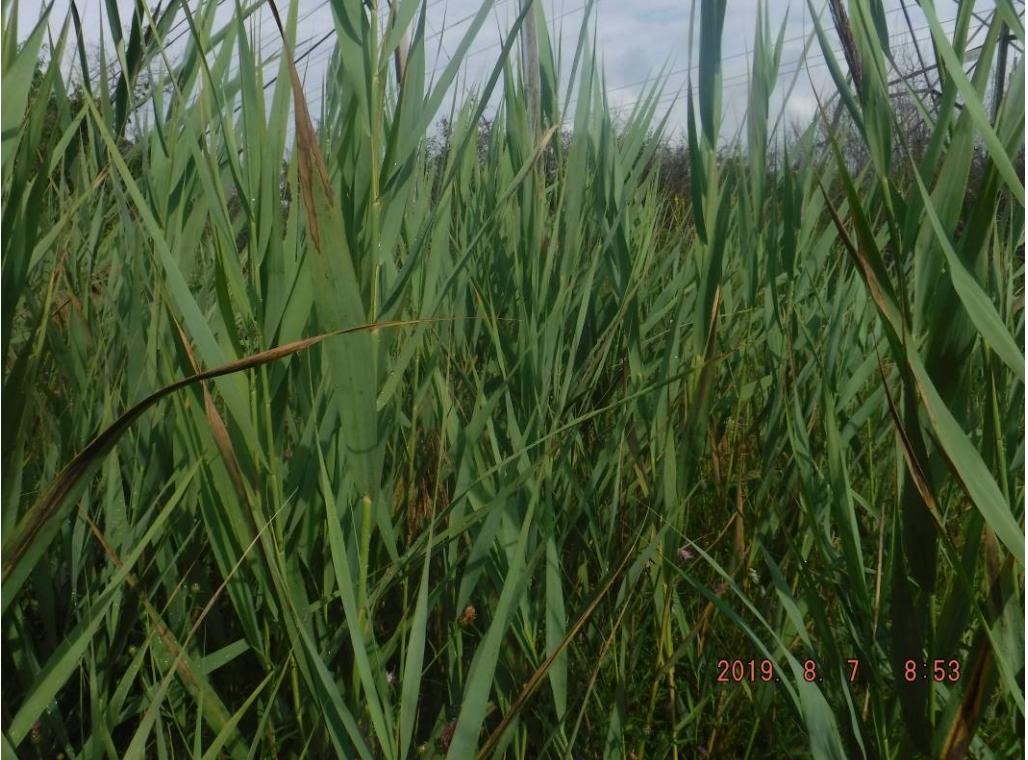
<b>Photo No. 10</b>

<b>Description:</b> Data Point 006 Overview of PEM Wetland 003.

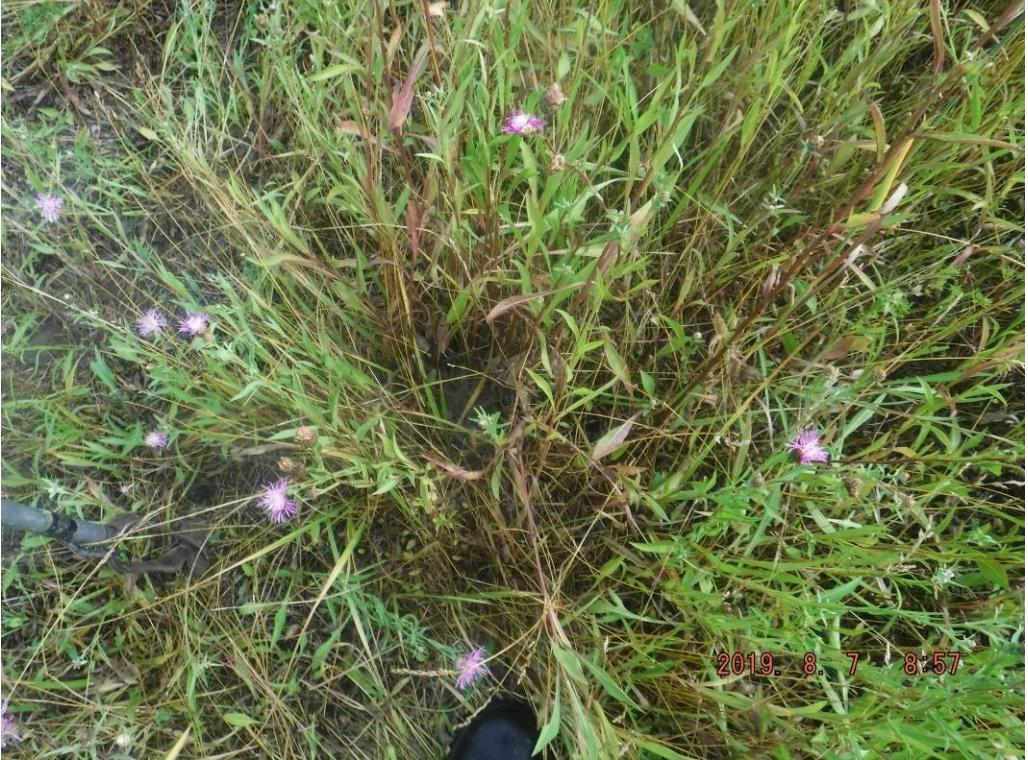
<b>Photo No. 11</b>

<div style="text-align: right; color: red; font-size: small;">2019. 8. 7 8:57</div>
<p>Facing North</p> <p><b>Description:</b> Data Point 007 Data Point for upland/dryland adjacent to Wetland 003.</p>

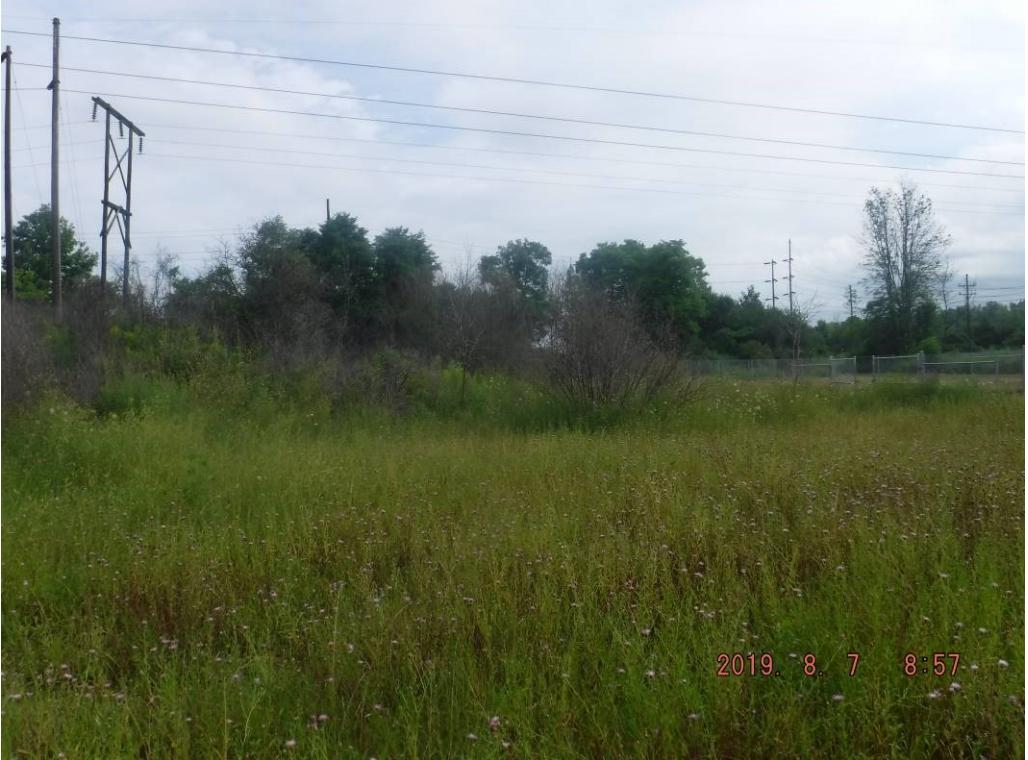
<b>Photo No. 12</b>

<div style="text-align: right; color: red; font-size: small;">2019. 8. 7 8:57</div>
<p>Facing North</p> <p><b>Description:</b> Data Point 007 Overview of upland/dryland adjacent to Wetland 003.</p>

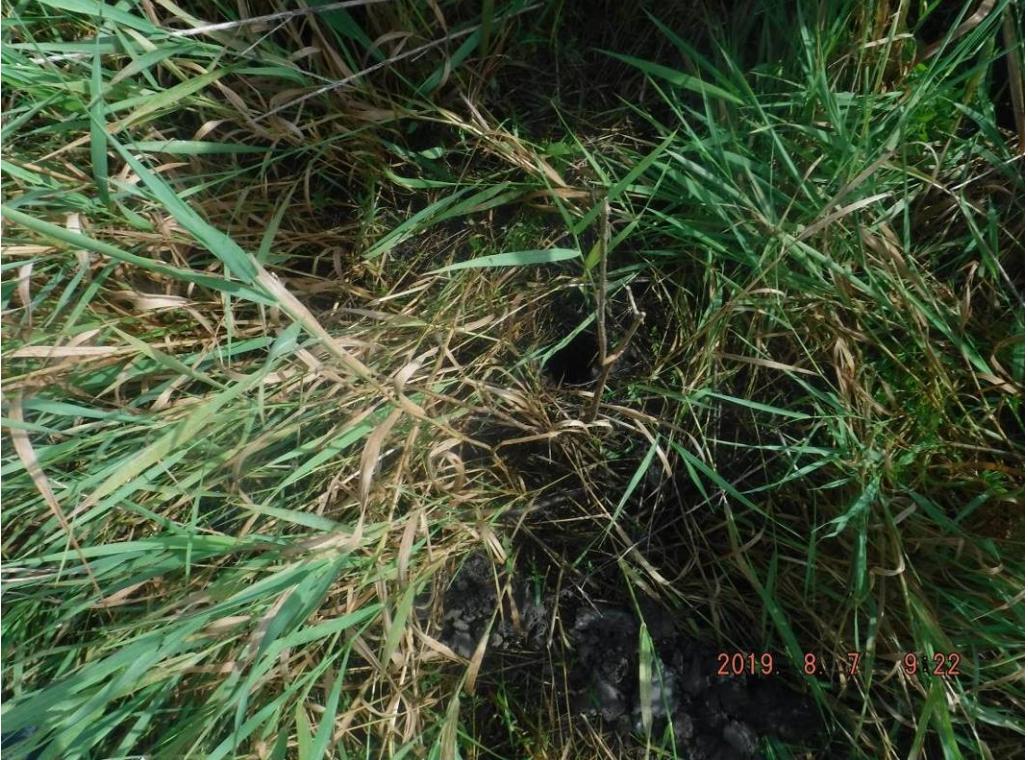
<b>Photo No. 13</b>

Facing North  <b>Description:</b> Data Point 008 PEM Data Point for Wetland 004.

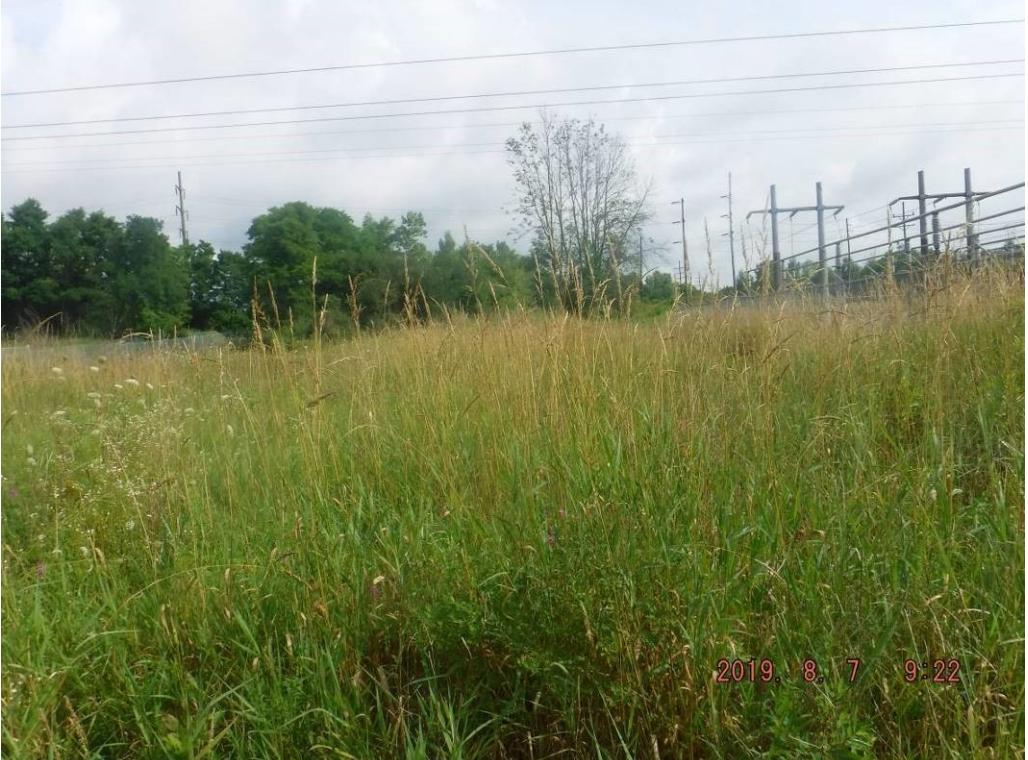
<b>Photo No. 14</b>

Facing North  <b>Description:</b> Data Point 008 Overview of PEM Wetland 004.

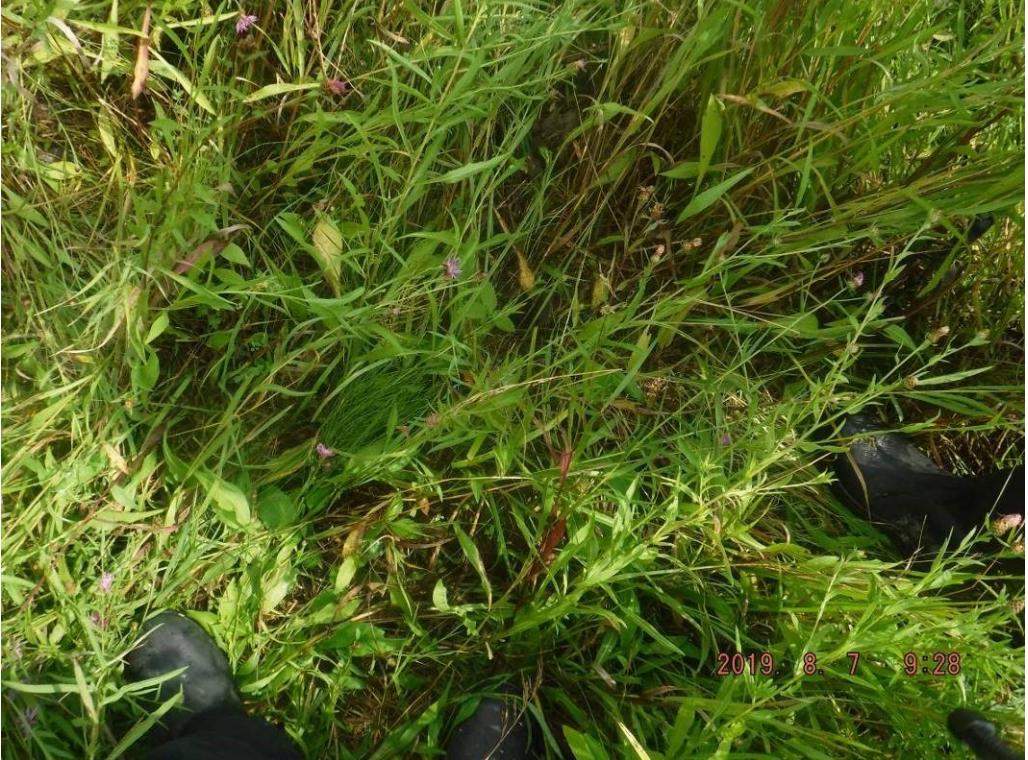
<b>Photo No. 15</b>

Facing North  <b>Description:</b> Data Point 009  Data Point for upland/dryland adjacent to Wetland 004 & Wetland 005.

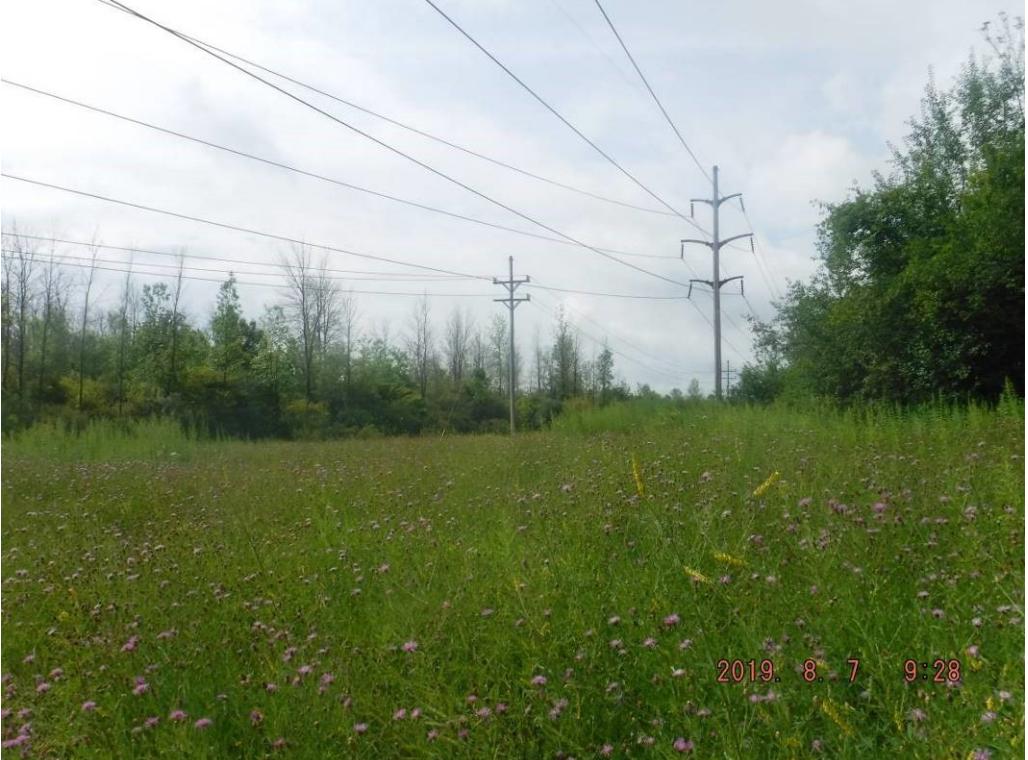
<b>Photo No. 16</b>

Facing South  <b>Description:</b> Data Point 009  Overview of upland/dryland adjacent to Wetland 004 & Wetland 005.

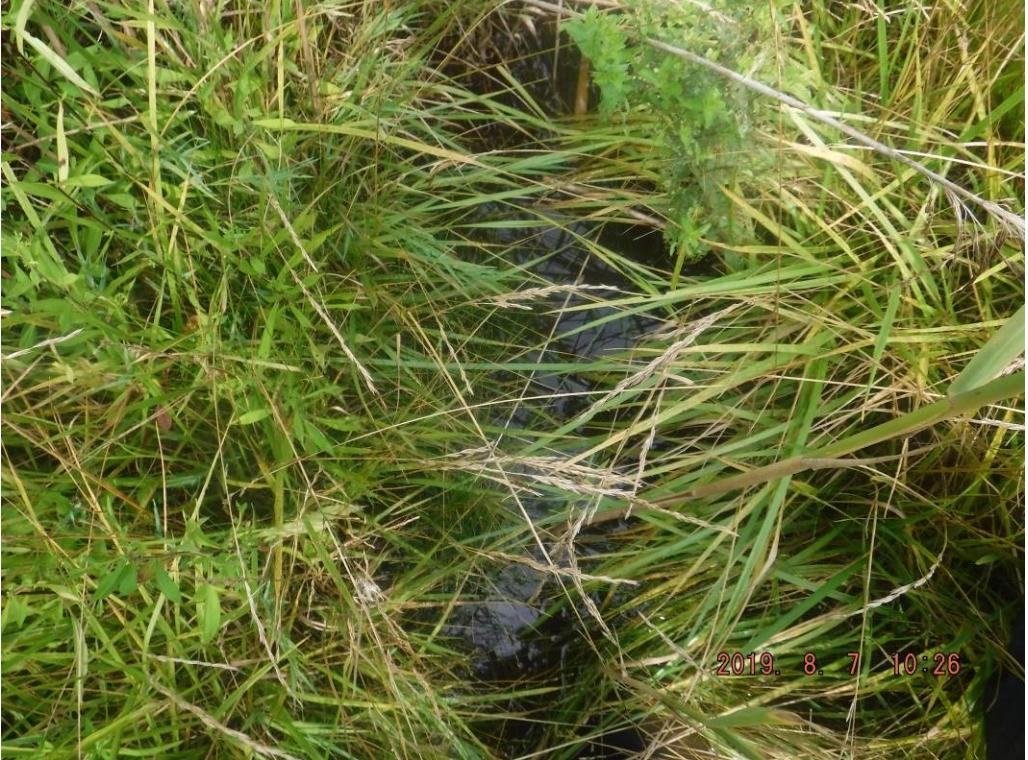
<b>Photo No. 17</b>

Facing North

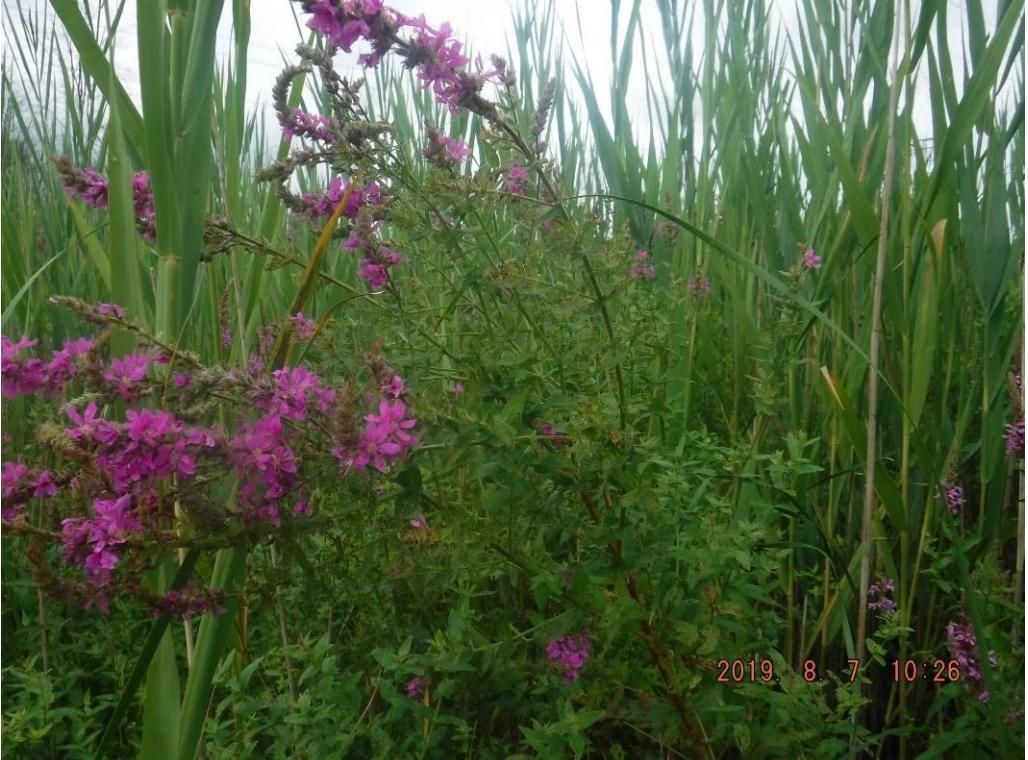
<b>Photo No. 18</b>

Facing West

**Description:**

Data Point 010

Overview of PEM Wetland 005. Located in NYSDEC Wetland LP-23.

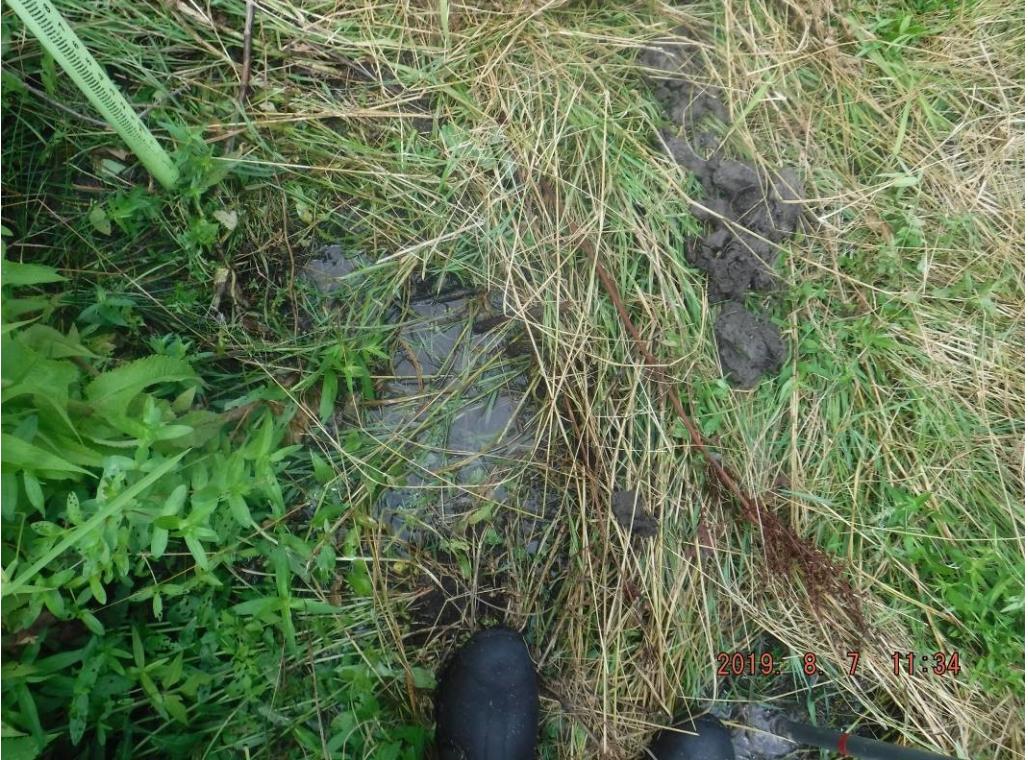
<b>Photo No. 19</b>

<p>2019. 8. 7 11:34</p>
<b>Description:</b> Data Point 011 PEM Data Point for Wetland 006.

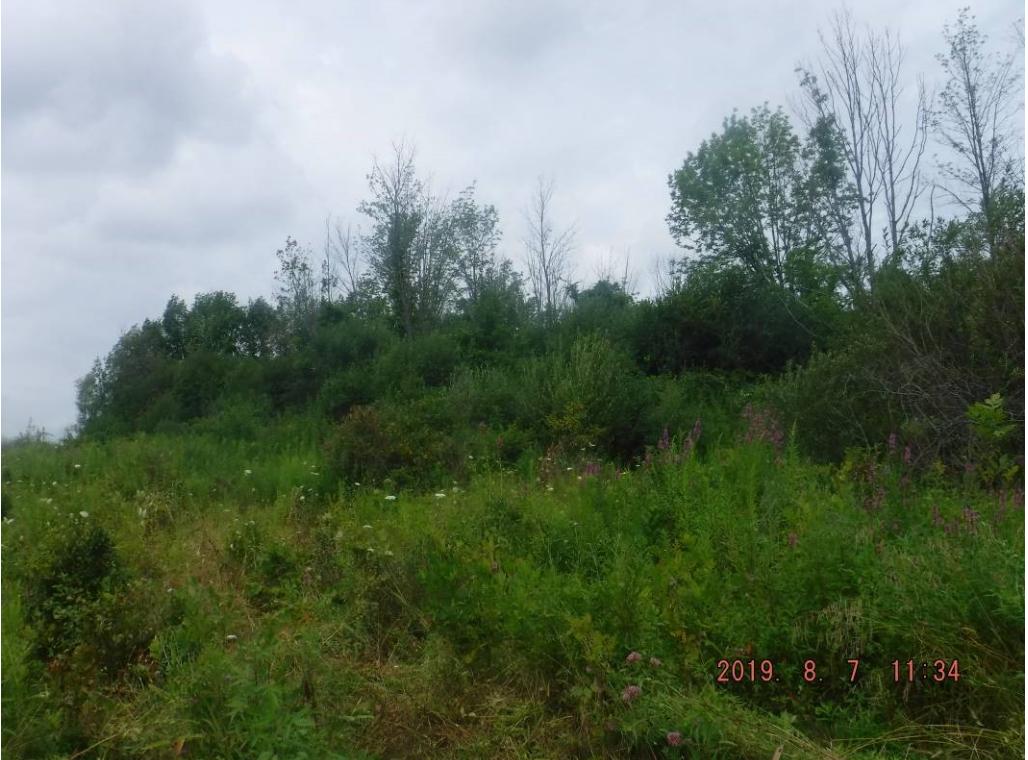
<b>Photo No. 20</b>

<p>2019. 8. 7 11:34</p>
<b>Description:</b> Data Point 011 Overview of PEM Wetland 006.

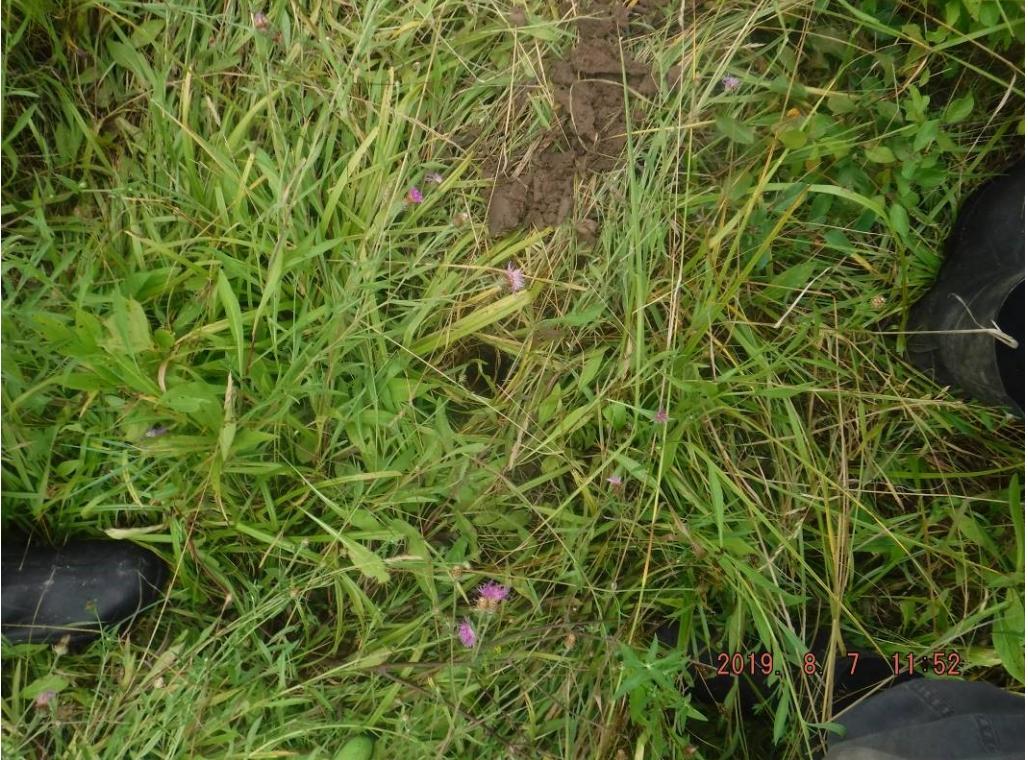
<b>Photo No. 21</b>

<b>Description:</b> Data Point 012 Data Point for upland/dryland adjacent to Wetland 006.

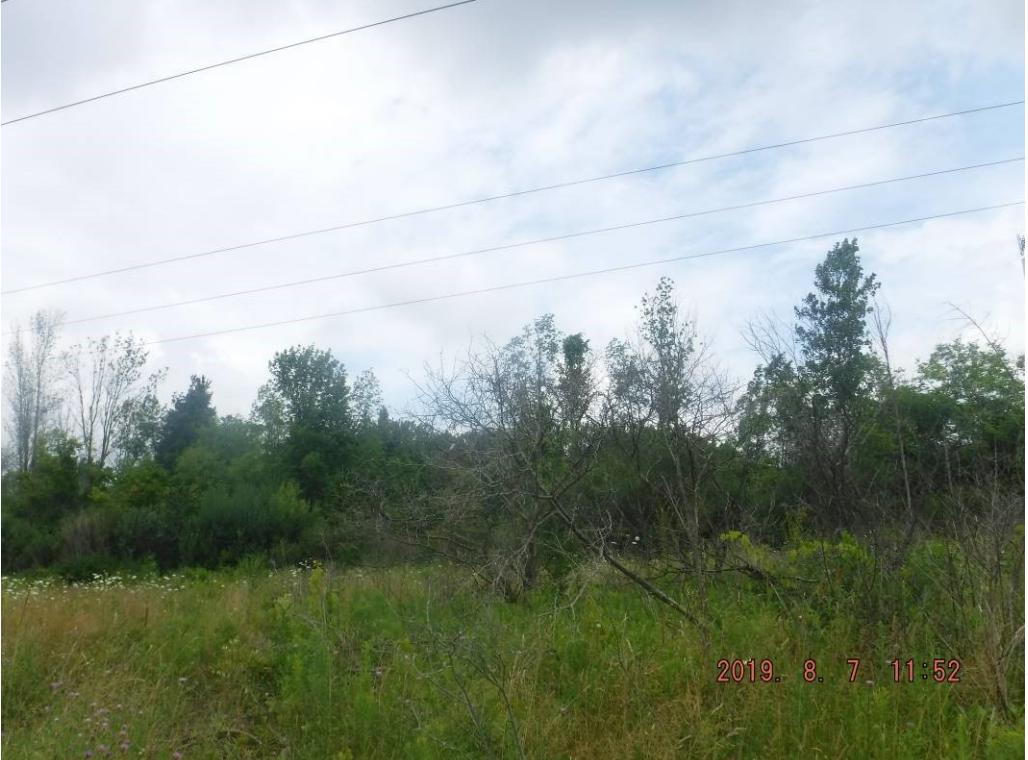
<b>Photo No. 22</b>

<b>Description:</b> Data Point 012 Overview of upland/dryland adjacent to Wetland 006.

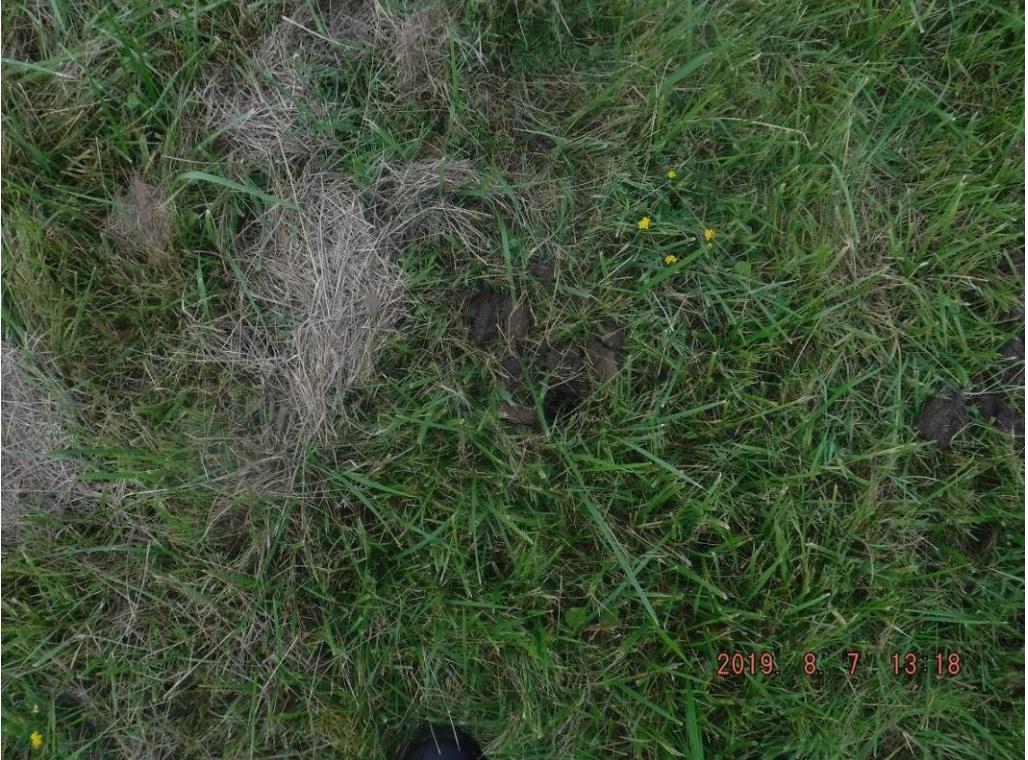
<b>Photo No. 23</b>

Facing North

<b>Description:</b> Data Point 013  Data Point for upland/dryland adjacent to Wetland 007.
---

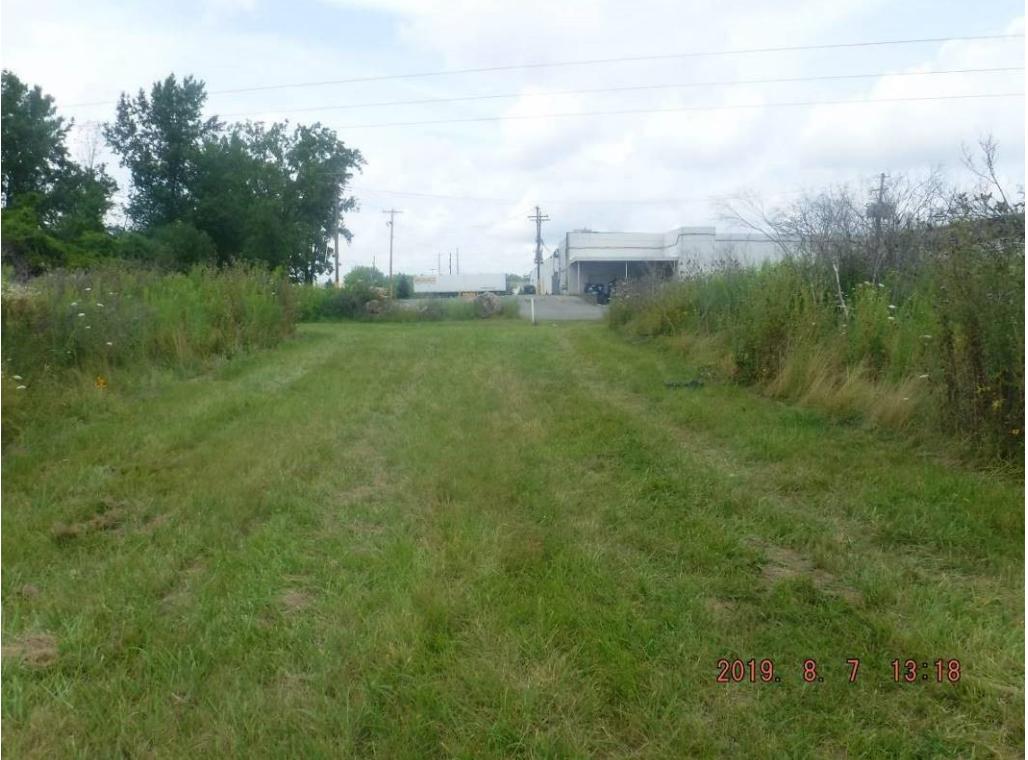
<b>Photo No. 24</b>

Facing North

<b>Description:</b> Data Point 013  Overview of upland/dryland adjacent to Wetland 007.
--

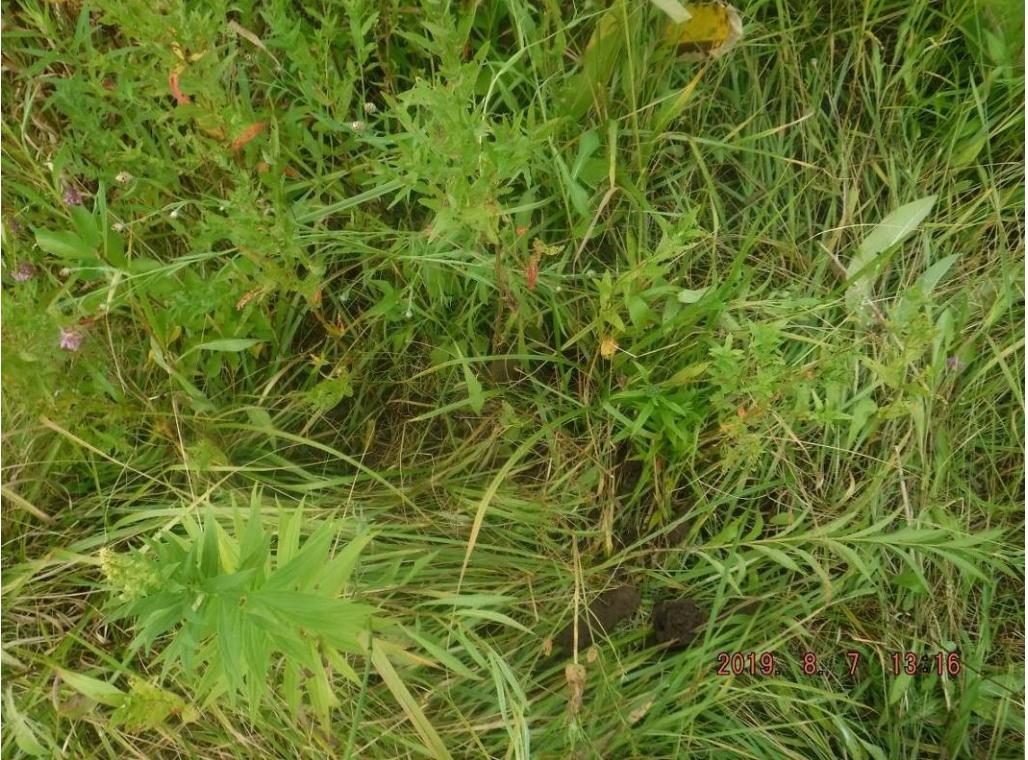
<b>Photo No. 25</b>

Facing North  <b>Description:</b> Data Point 014  PEM Data Point for Wetland 007.

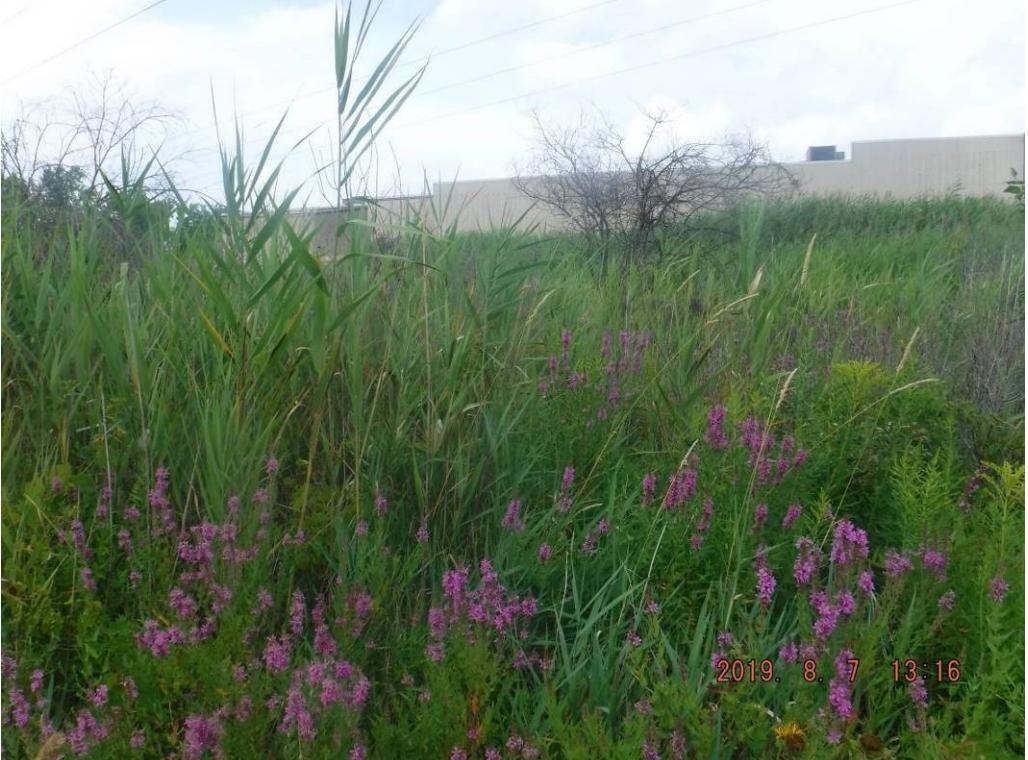
<b>Photo No. 26</b>

Facing North  <b>Description:</b> Data Point 014  Overview of PEM Wetland 007.

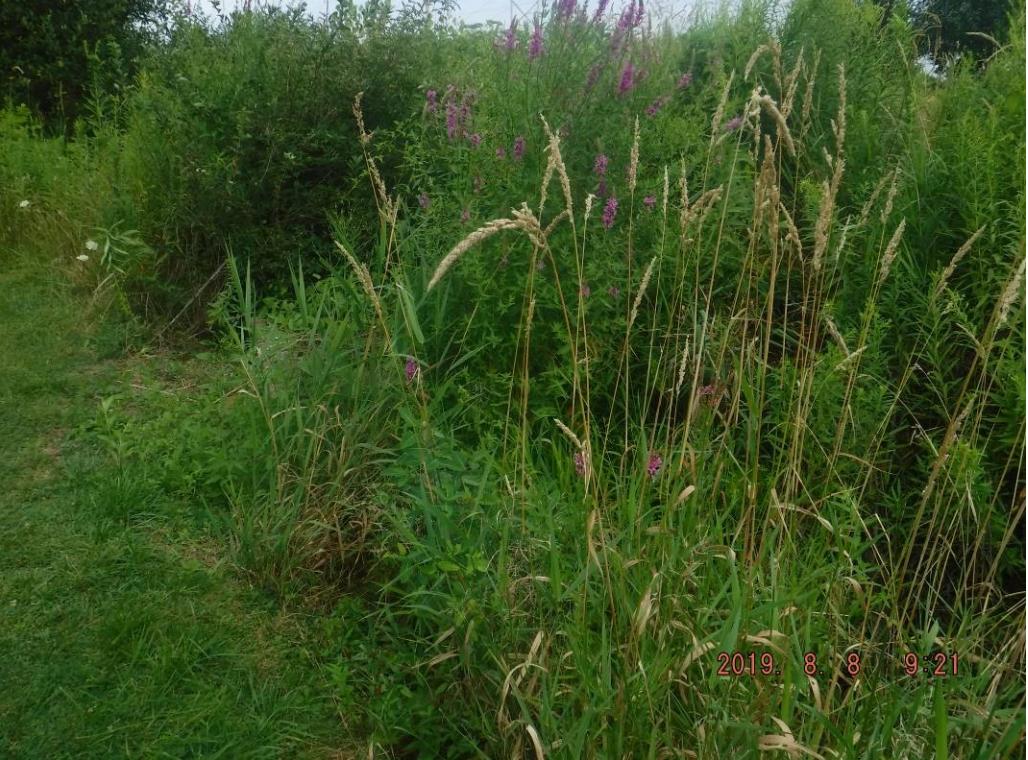
<b>Photo No. 27</b>

<p>2019. 8. 8 9:21</p>
<b>Description:</b> Data Point 015 Ditch Data Point for non-jurisdictional intermittent Ditch 001.

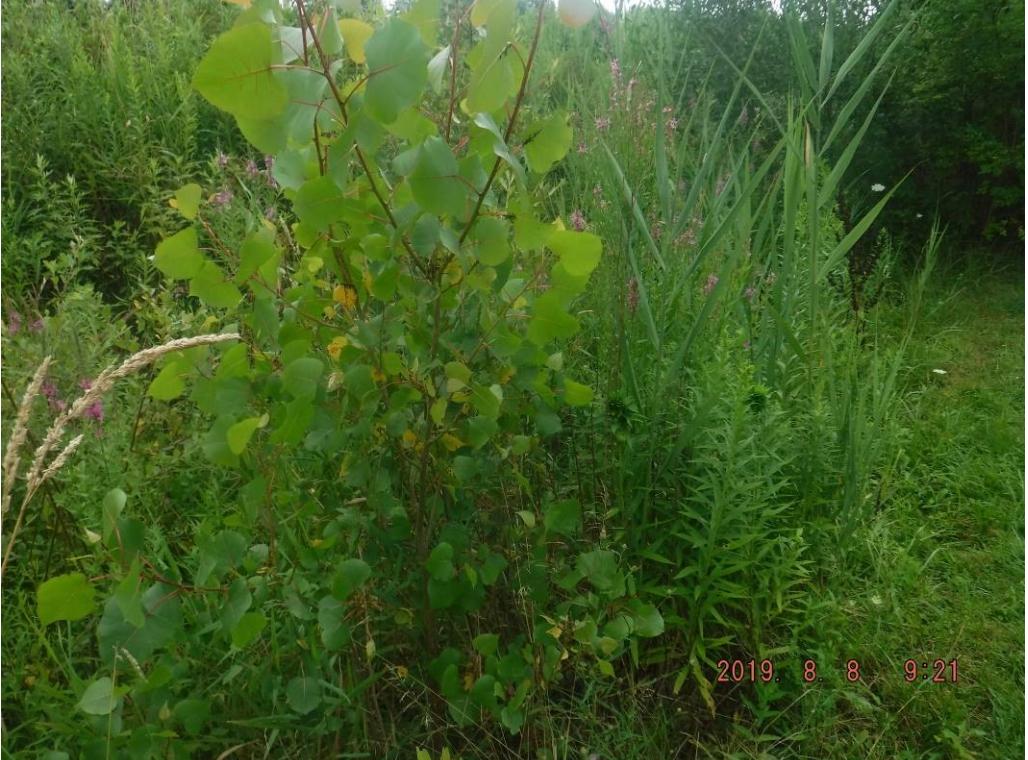
<b>Photo No. 28</b>

<p>2019. 8. 8 9:21</p>
<b>Description:</b> Data Point 015 Ditch Data Point for non-jurisdictional intermittent Ditch 001.
