## **Lockport-Batavia Line #112 Rebuild Project**

### **EM&CP Update**

### **Replacement Appendix G (SWPPP)**

*(Revised January 2026; Replaces Version Filed June 2025)*

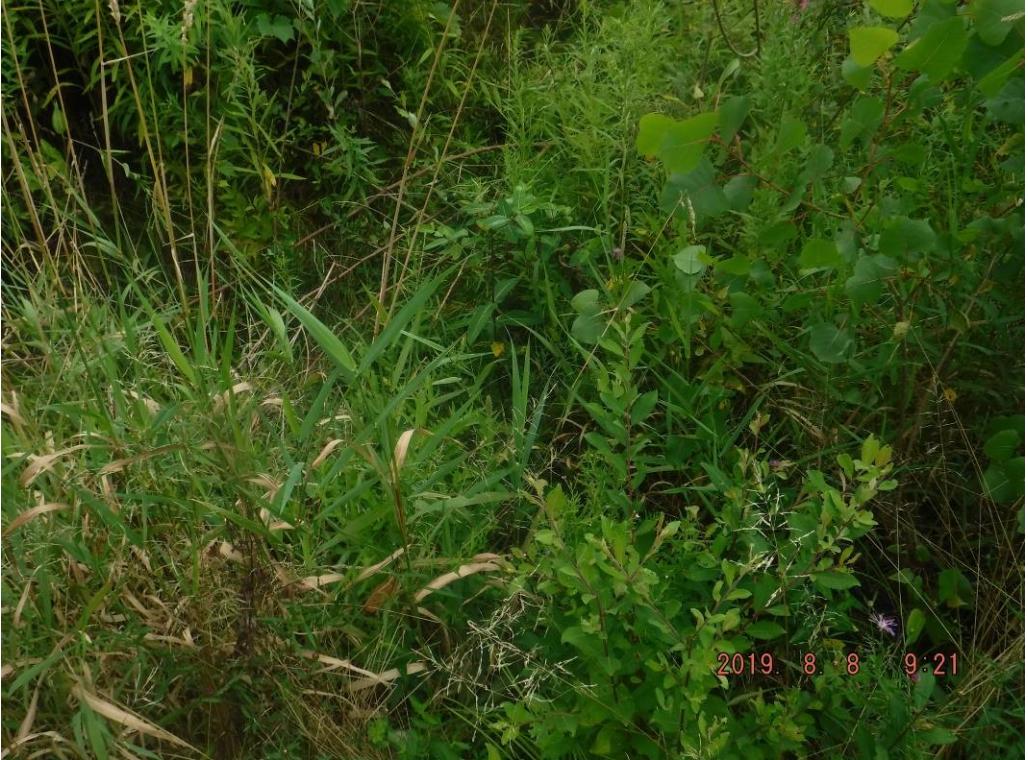
<p><b>Photo No. 29</b></p> <p>Facing North/ Right Bank to Left Bank</p>	<p><b>Description:</b></p> <p>Data Point 015 Ditch Data Point for non-jurisdictional intermittent Ditch 001.</p>

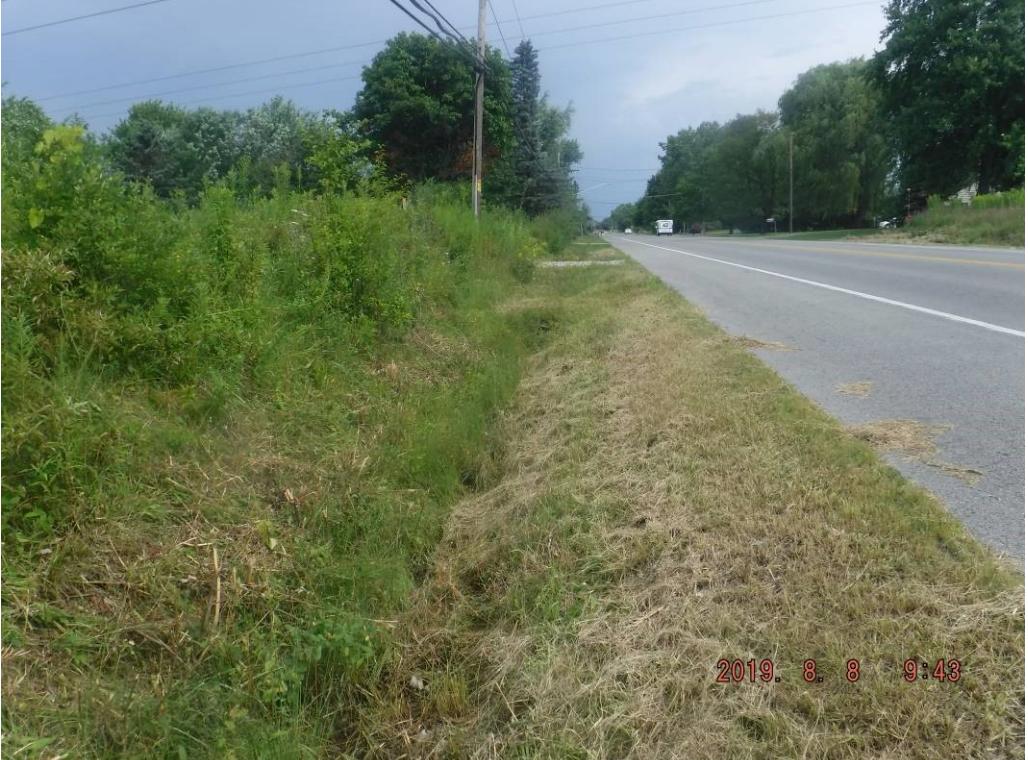
<p><b>Photo No. 30</b></p> <p>Facing North/ Upstream</p>	<p><b>Description:</b></p> <p>Data Point 016 Ditch Data Point for non-jurisdictional ephemeral Ditch 002.</p>

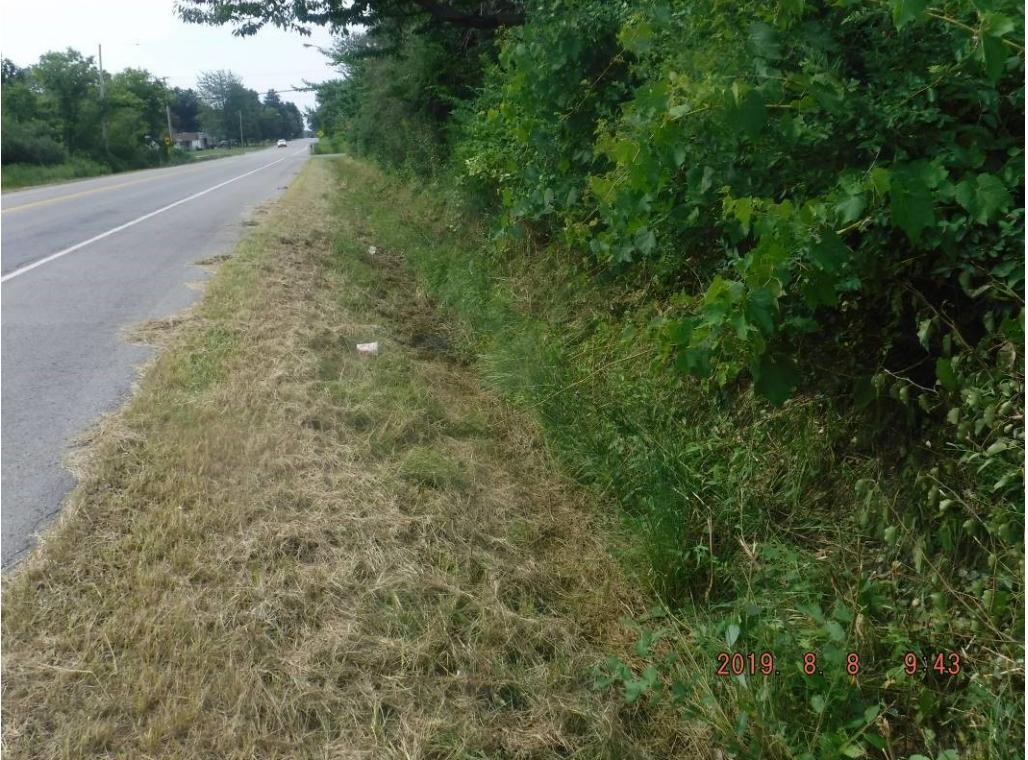
<b>Photo No. 31</b>

<b>Description:</b> Data Point 016 Ditch Data Point for non-jurisdictional ephemeral Ditch 002.

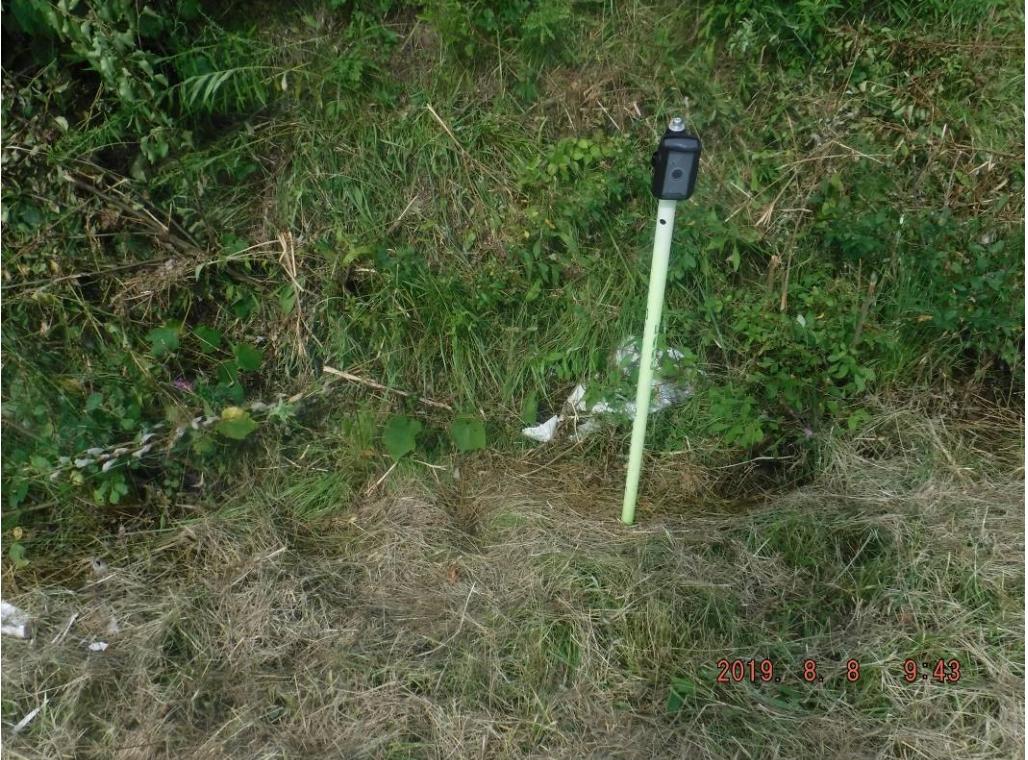
<b>Photo No. 32</b>

<b>Description:</b> Data Point 016 Ditch Data Point for non-jurisdictional ephemeral Ditch 002.

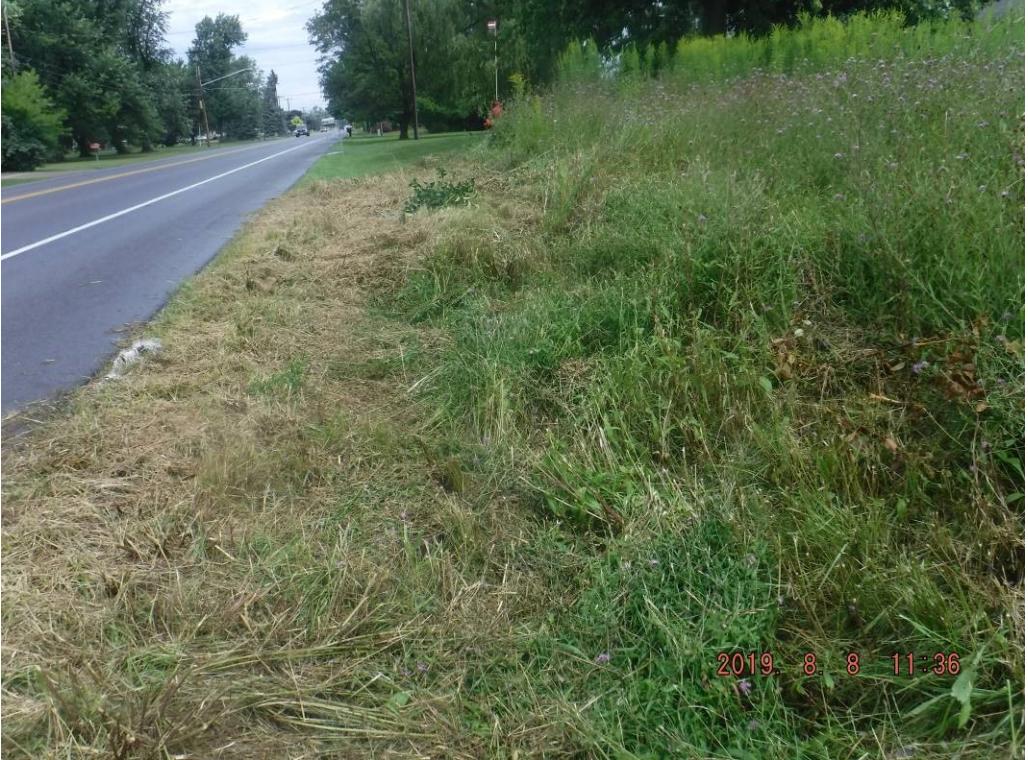
<b>Photo No. 33</b>

<p>Facing North/ Upstream</p> <p><b>Description:</b> Data Point 017 Ditch Data Point for non-jurisdictional ephemeral Ditch 003.</p>

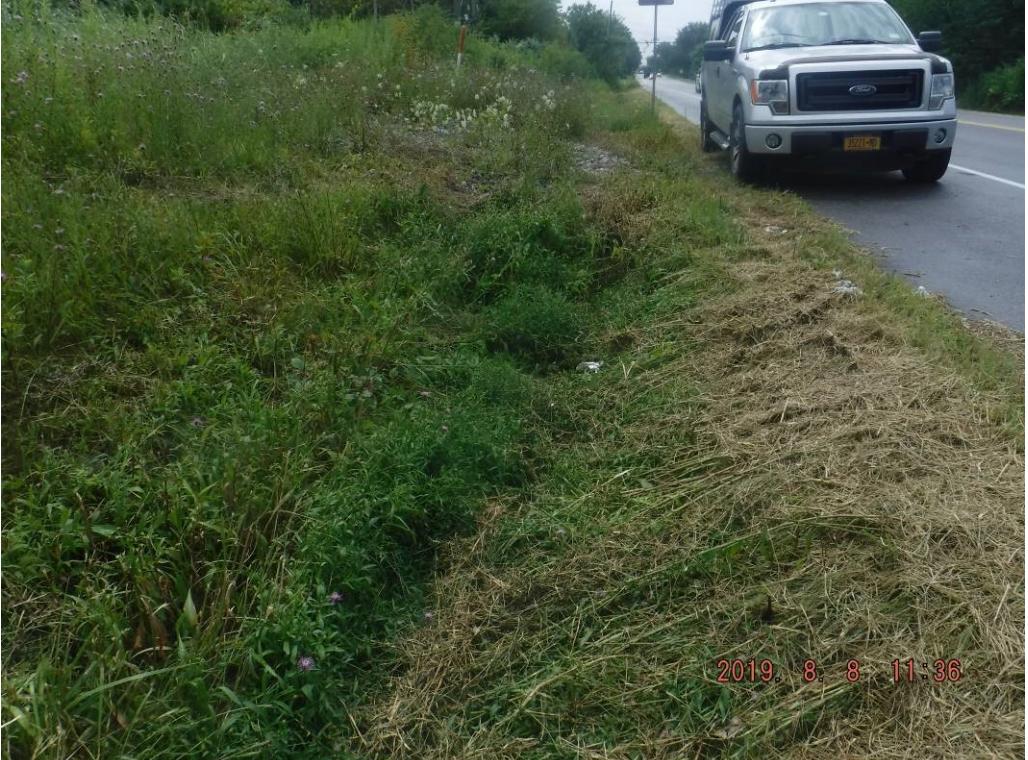
<b>Photo No. 34</b>

<p>Facing South/ Downstream</p> <p><b>Description:</b> Data Point 017 Ditch Data Point for non-jurisdictional ephemeral Ditch 003.</p>

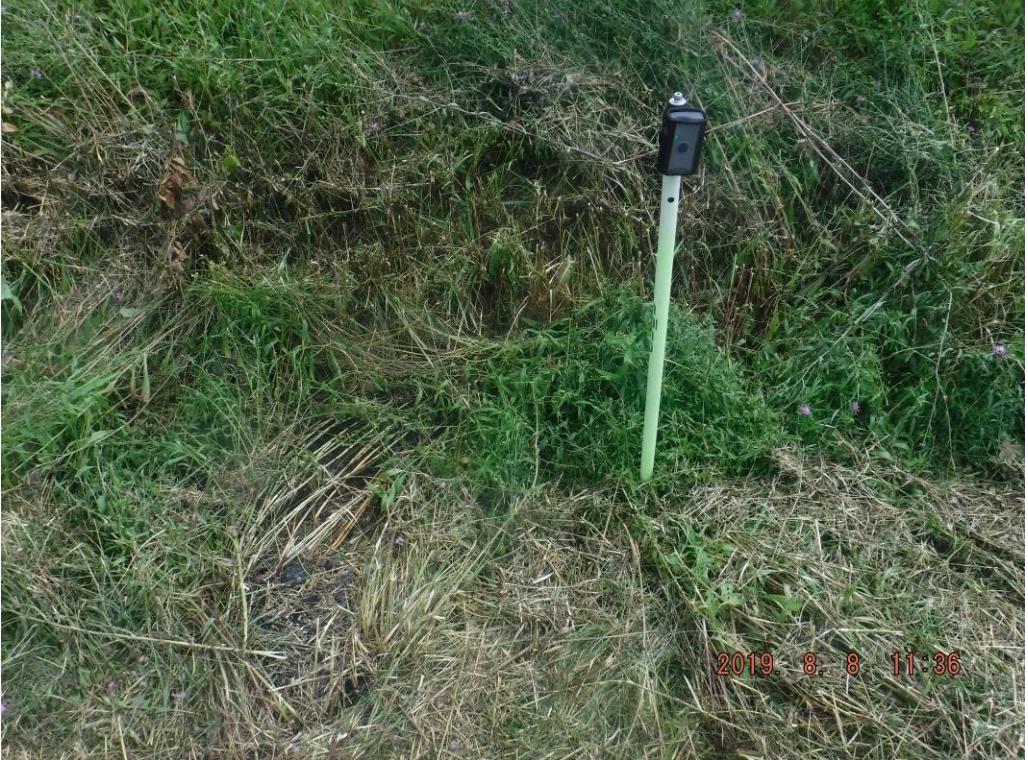
<p><b>Photo No. 35</b></p> <p>Facing East/ Right Bank to Left Bank</p> <p><b>Description:</b> Data Point 017 Ditch Data Point for non-jurisdictional ephemeral Ditch 003.</p>

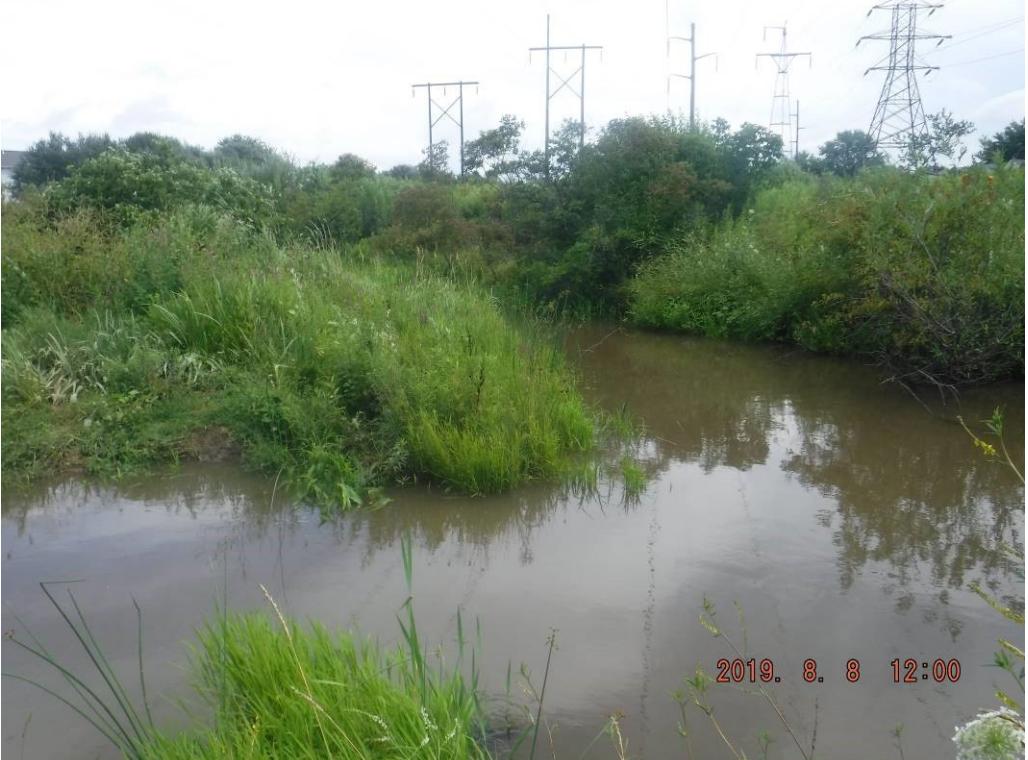
<p><b>Photo No. 36</b></p> <p>Facing North/ Upstream</p> <p><b>Description:</b> Data Point 018 Stream Data Point for perennial Stream 002. Stream 002, an unnamed tributary to Tonawanda Creek.</p>

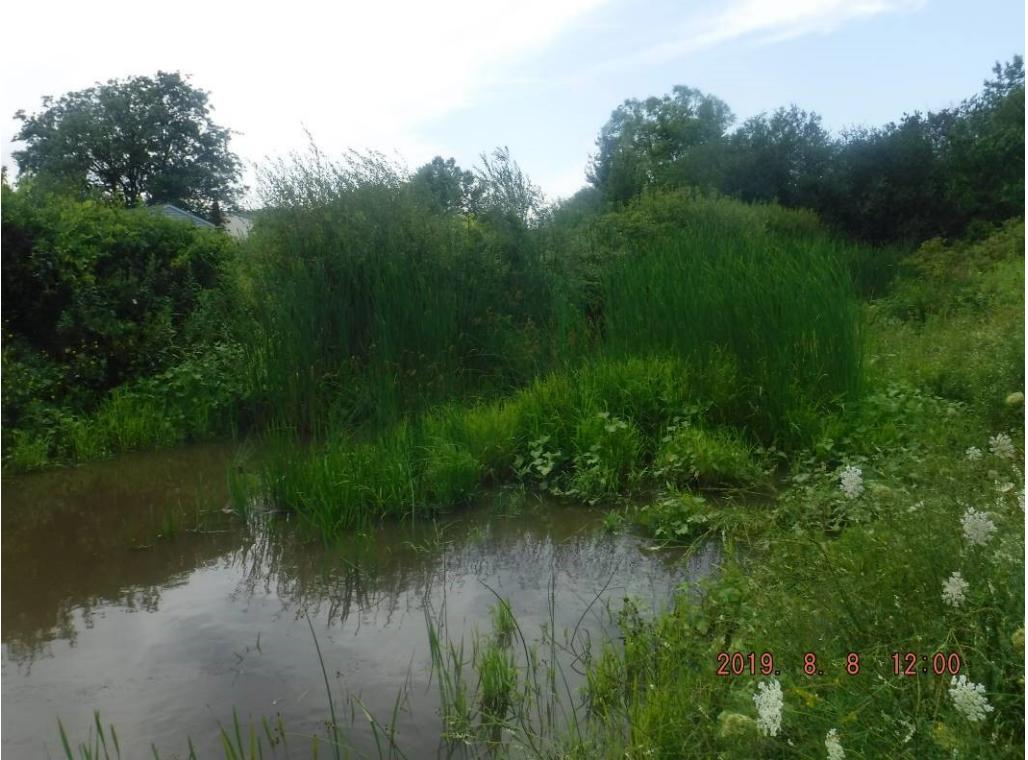
<b>Photo No. 37</b>

<b>Description:</b> Data Point 018  Stream Data Point for perennial Stream 002. Stream 002, an unnamed tributary to Tonawanda Creek.

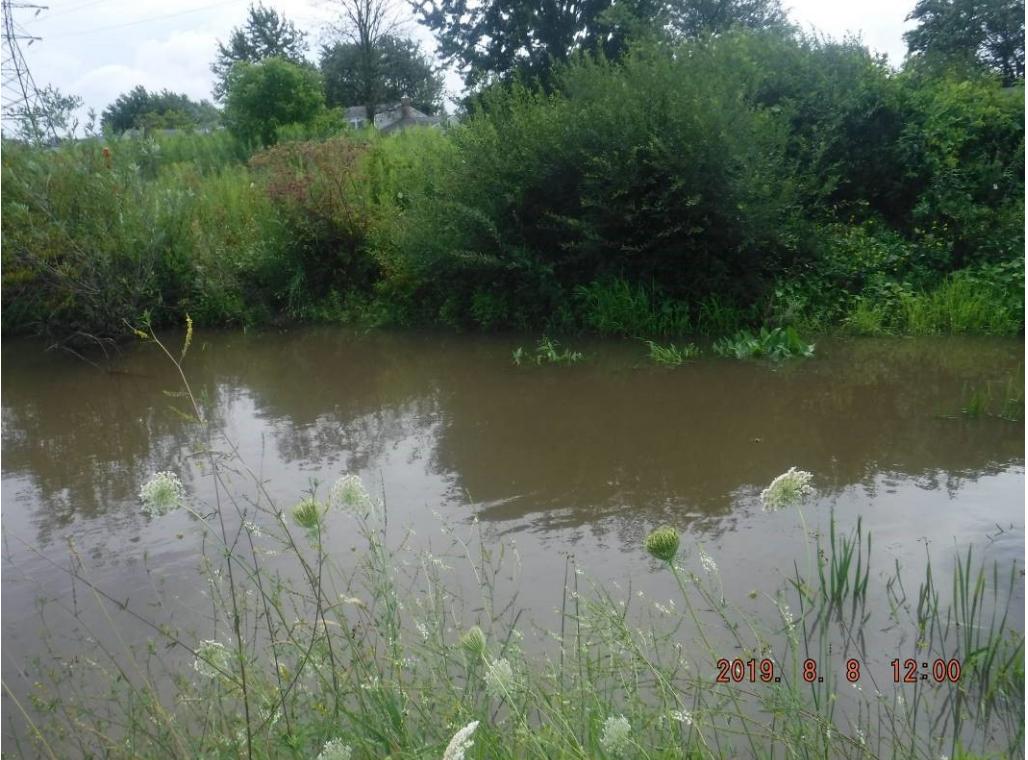
<b>Photo No. 38</b>

<b>Description:</b> Data Point 018  Stream Data Point for perennial Stream 002. Stream 002, an unnamed tributary to Tonawanda Creek.

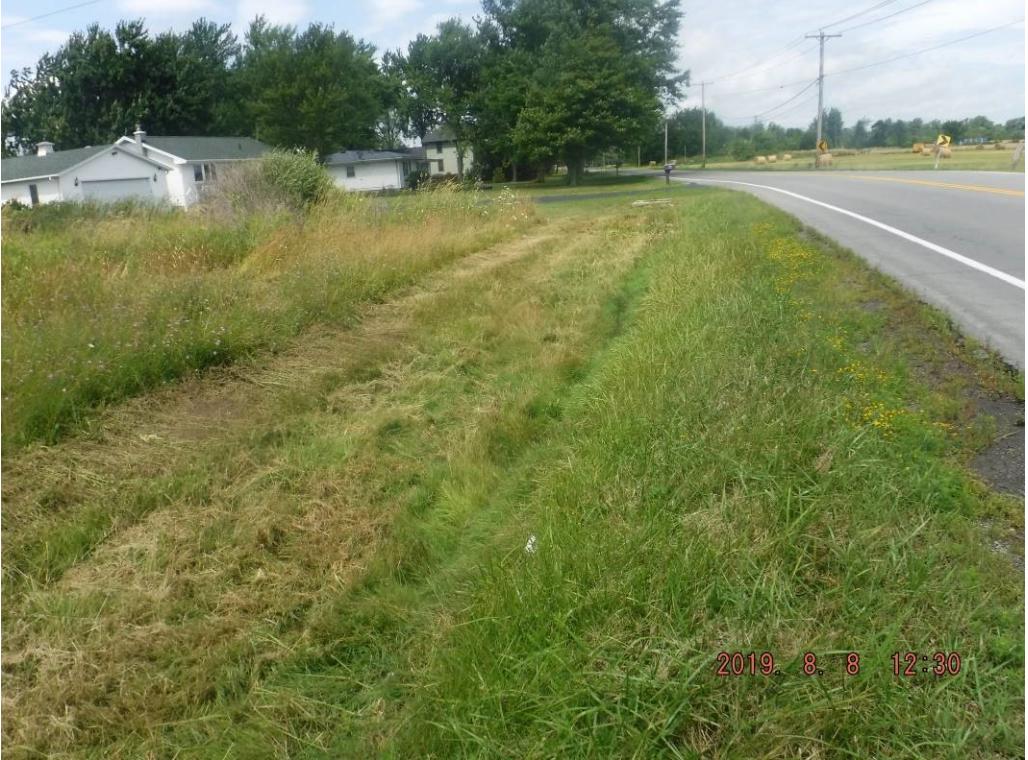
<p><b>Photo No. 39</b></p> <p>Facing North/ Upstream</p> <p><b>Description:</b> Data Point 019 Ditch Data Point for non-jurisdictional intermittent Ditch 004.</p>

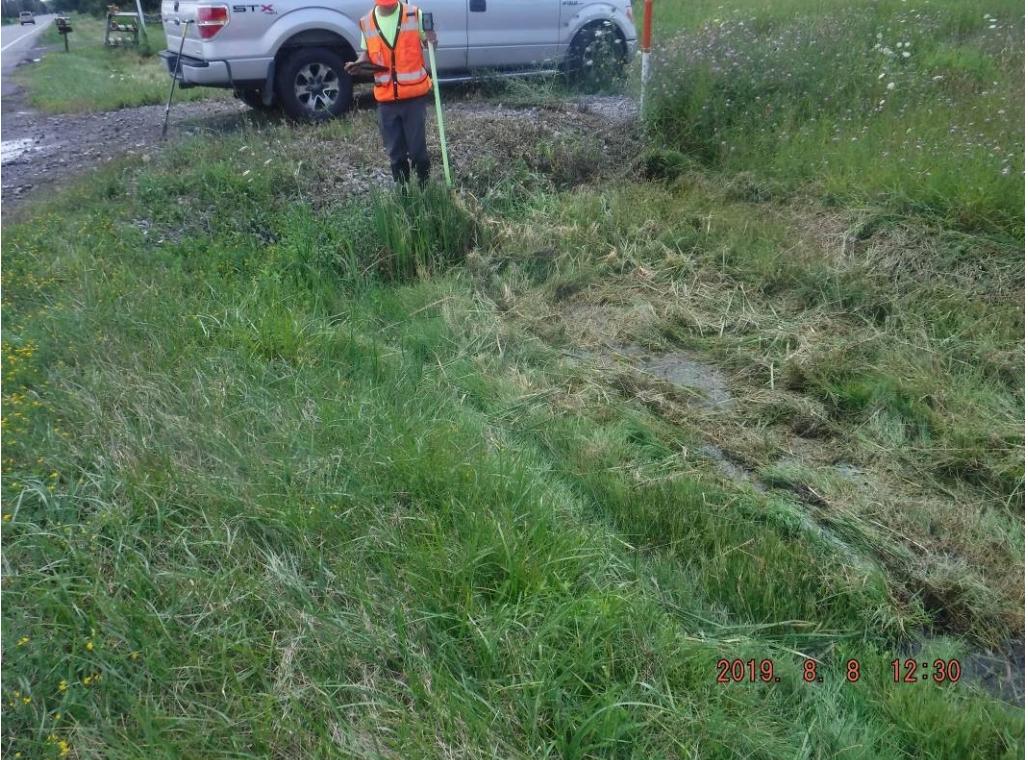
<p><b>Photo No. 40</b></p> <p>Facing South/ Downstream</p> <p><b>Description:</b> Data Point 019 Ditch Data Point for non-jurisdictional intermittent Ditch 004.</p>

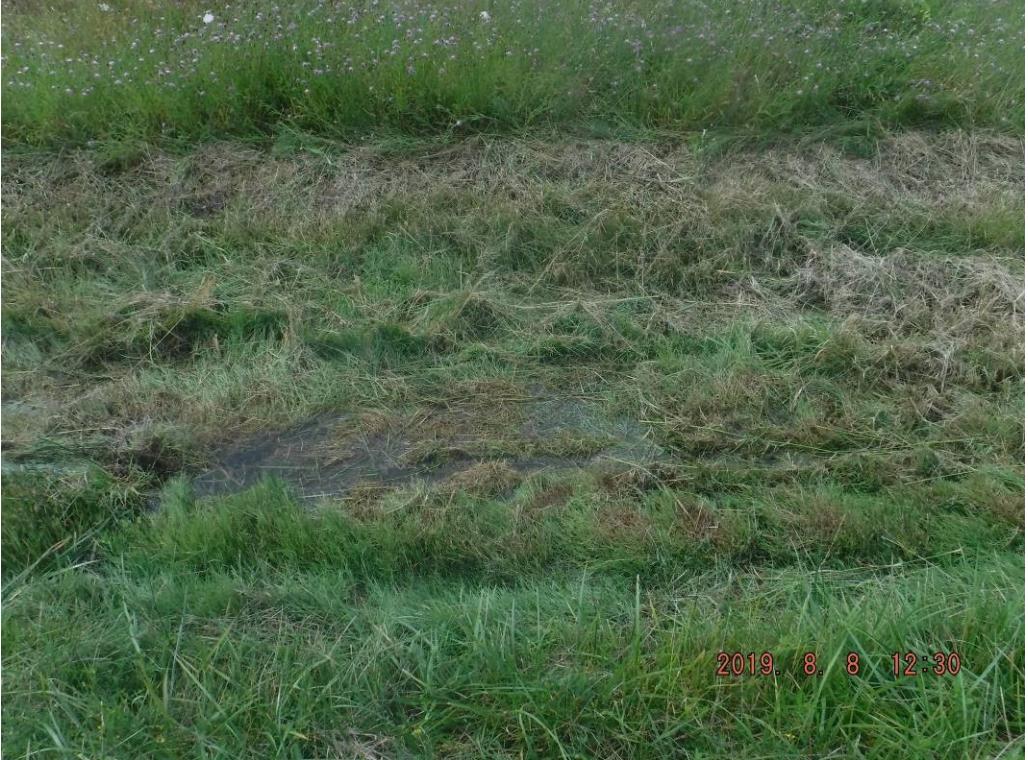
<b>Photo No. 41</b>

<p>Facing West/ Left Bank to Right Bank</p> <p><b>Description:</b> Data Point 019 Ditch Data Point for non-jurisdictional intermittent Ditch 004.</p>

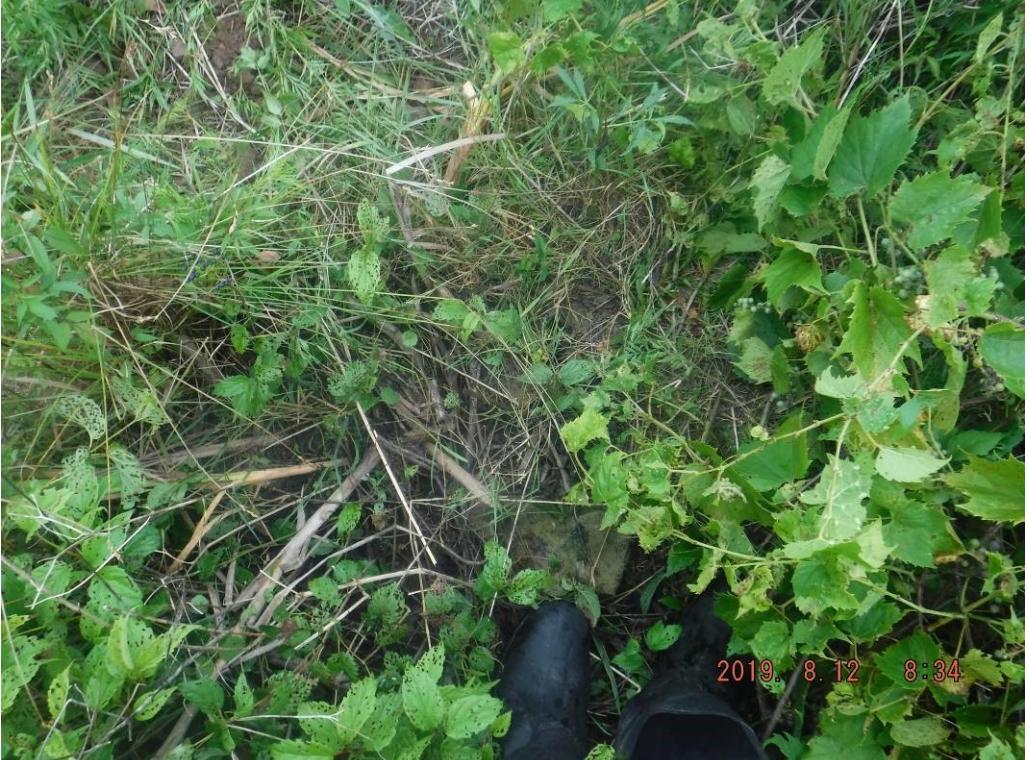
<b>Photo No. 42</b>

<p>Facing North</p> <p><b>Description:</b> Data Point 020 PEM Data Point for Wetland 008.</p>

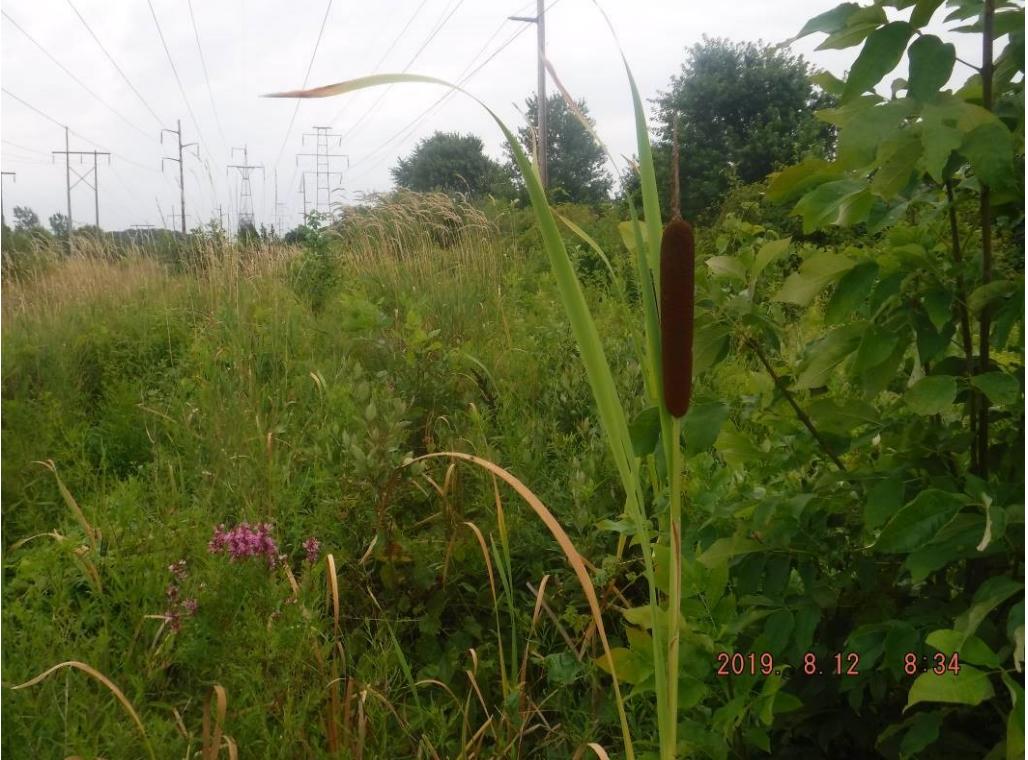
<b>Photo No. 43</b>

<p>2019. 8. 12 8:34</p>
<b>Description:</b> Data Point 020 Overview of PEM Wetland 008.

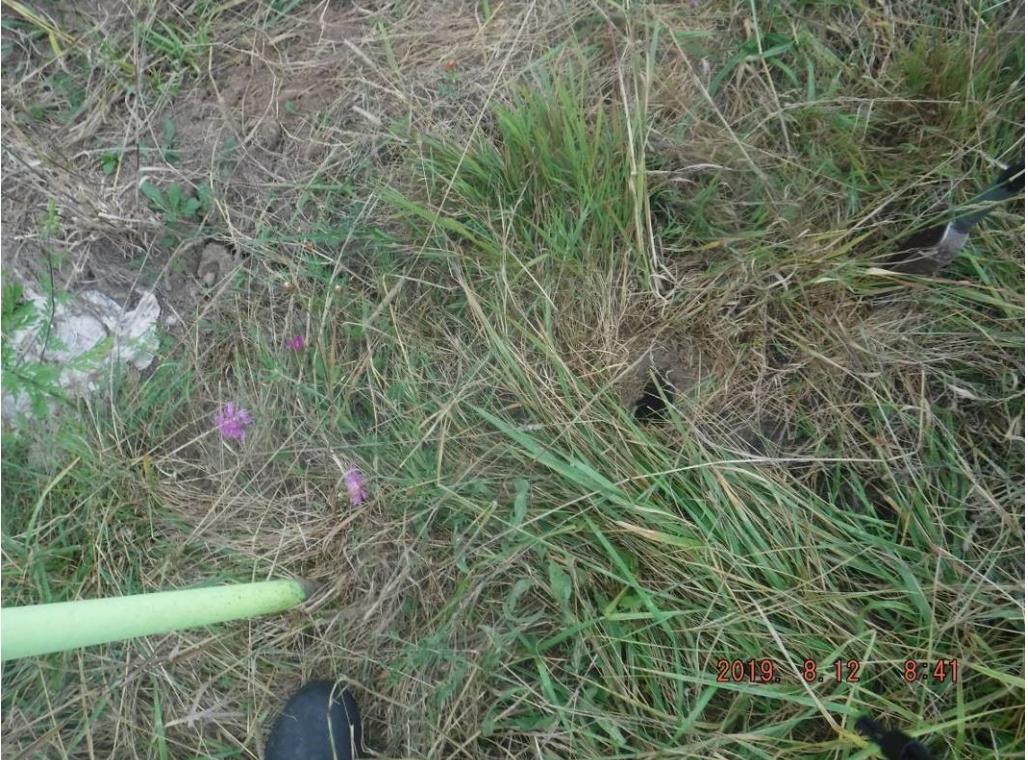
<b>Photo No. 44</b>

<p>2019. 8. 12 8:41</p>
<b>Description:</b> Data Point 021 Data Point for upland/dryland adjacent to Wetland 008.

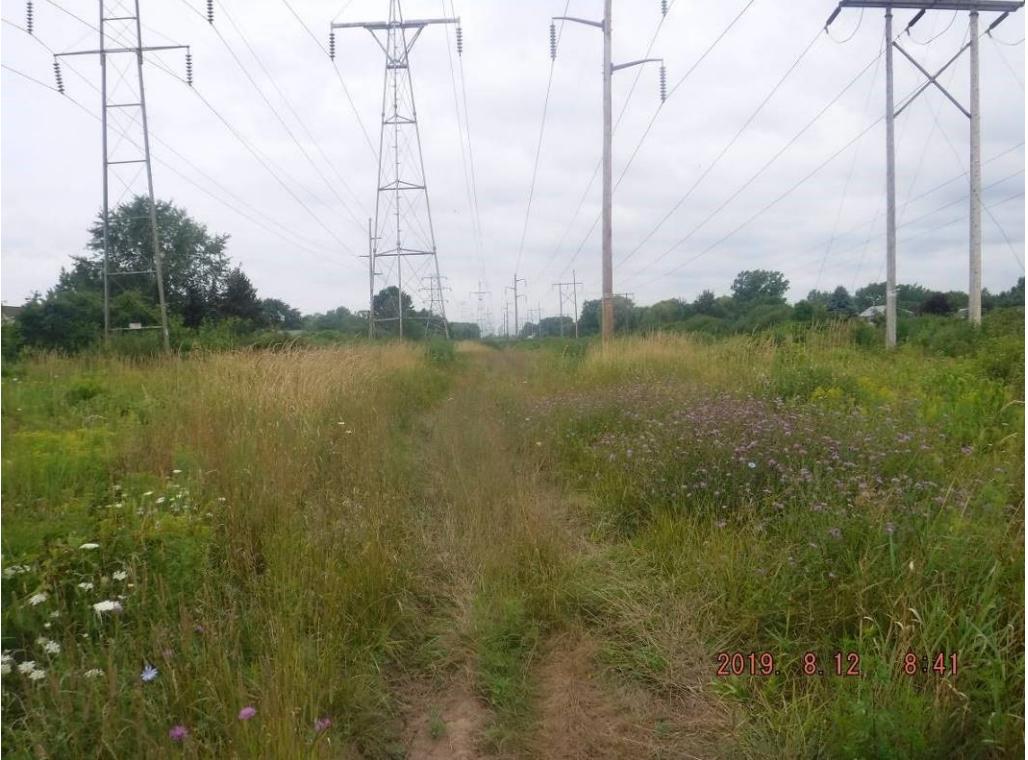
<b>Photo No. 45</b>

<p>Facing West</p> <p><b>Description:</b> Data Point 021 Overview of upland/dryland adjacent to Wetland 008.</p>

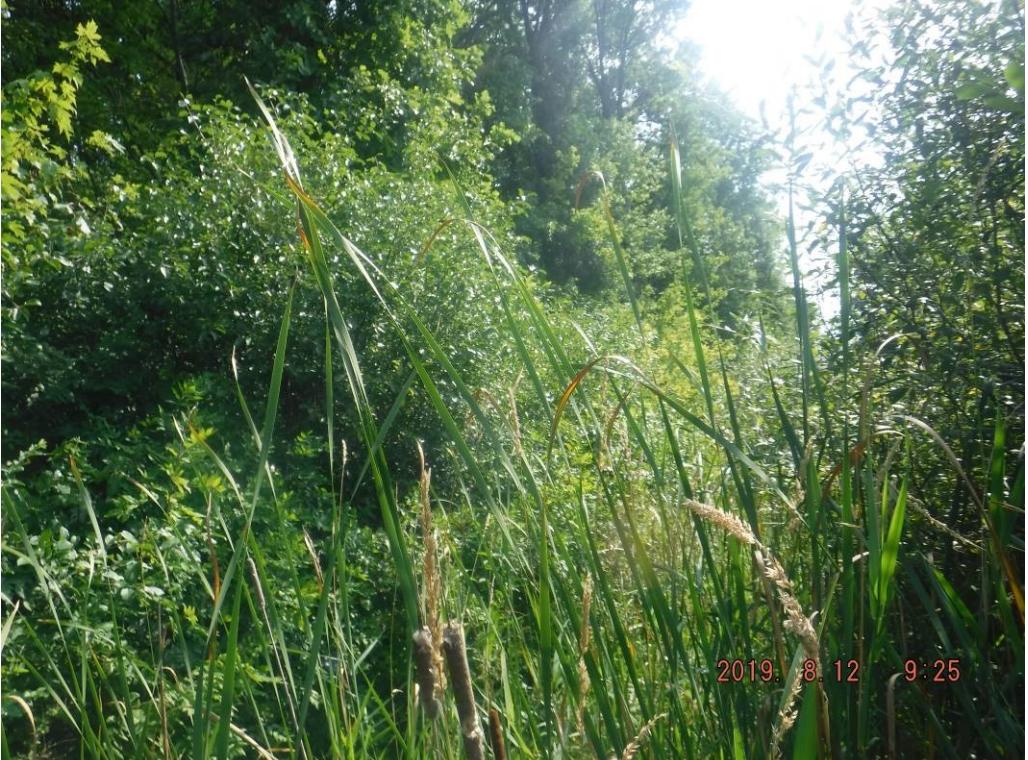
<b>Photo No. 46</b>

<p>Facing East/Upstream</p> <p><b>Description:</b> Data Point 022 Stream Data Point for intermittent Stream 003. Stream 003, an unnamed tributary to Mud Creek.</p>

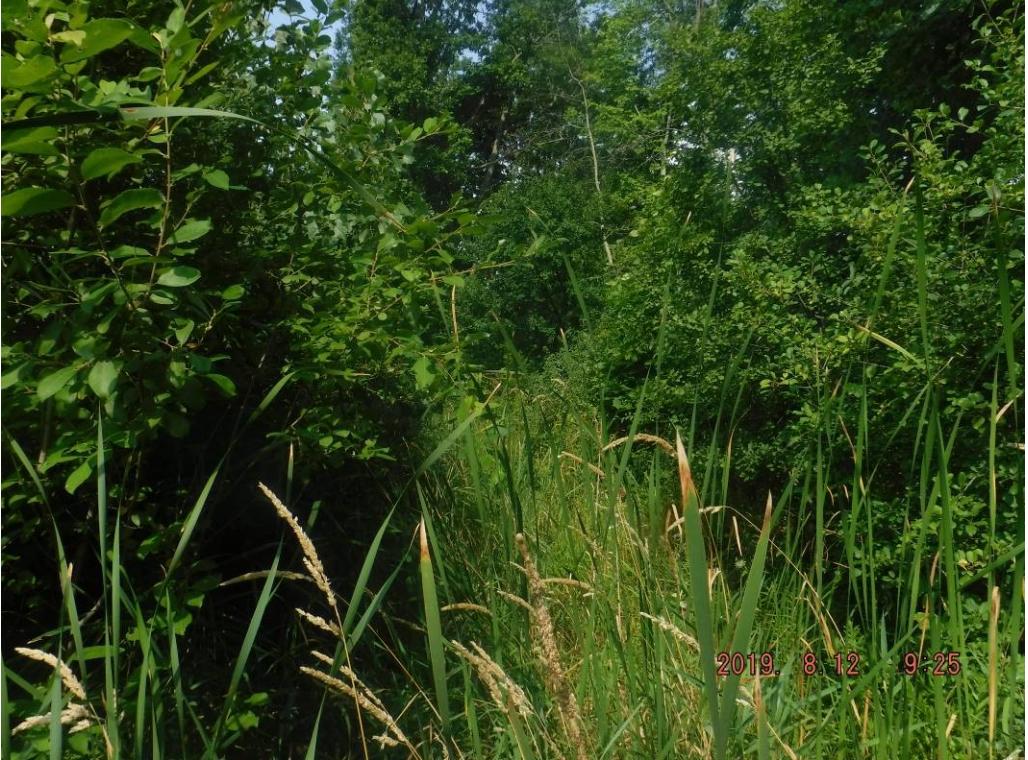
<p><b>Photo No. 47</b></p> <p>Facing West/ Downstream</p> <p><b>Description:</b> Data Point 022 Stream Data Point for intermittent Stream 003. Stream 003, an unnamed tributary to Mud Creek.</p>

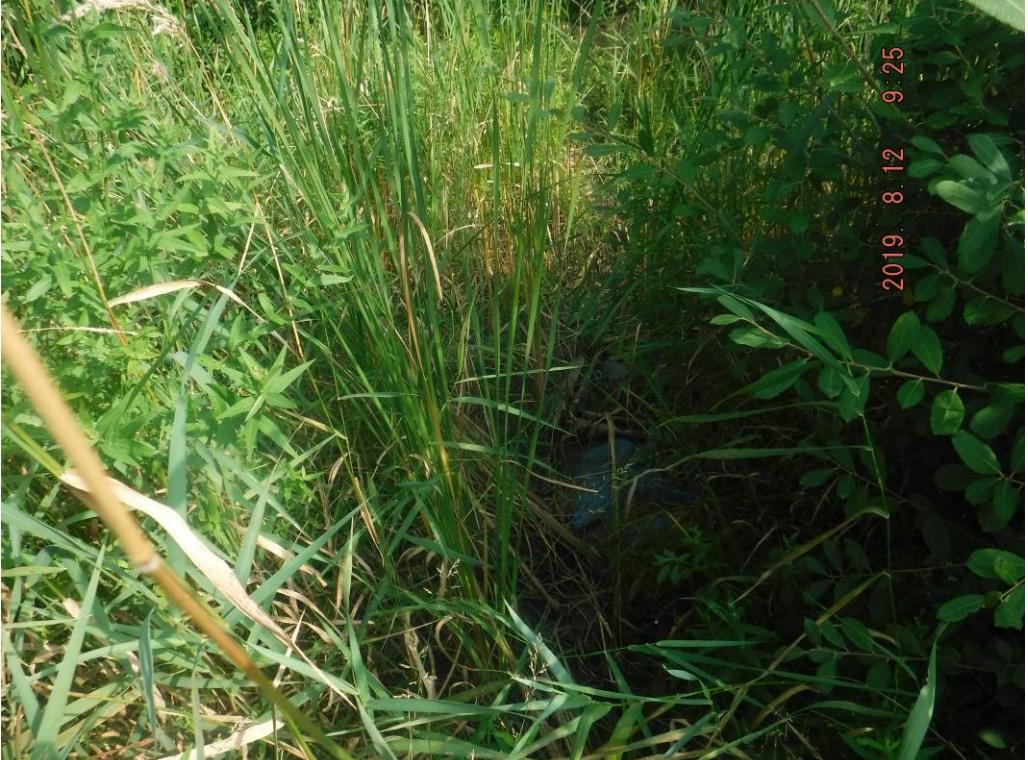
<p><b>Photo No. 48</b></p> <p>Facing North/ Left Bank to Right Bank</p> <p><b>Description:</b> Data Point 022 Stream Data Point for intermittent Stream 003. Stream 003, an unnamed tributary to Mud Creek.</p>

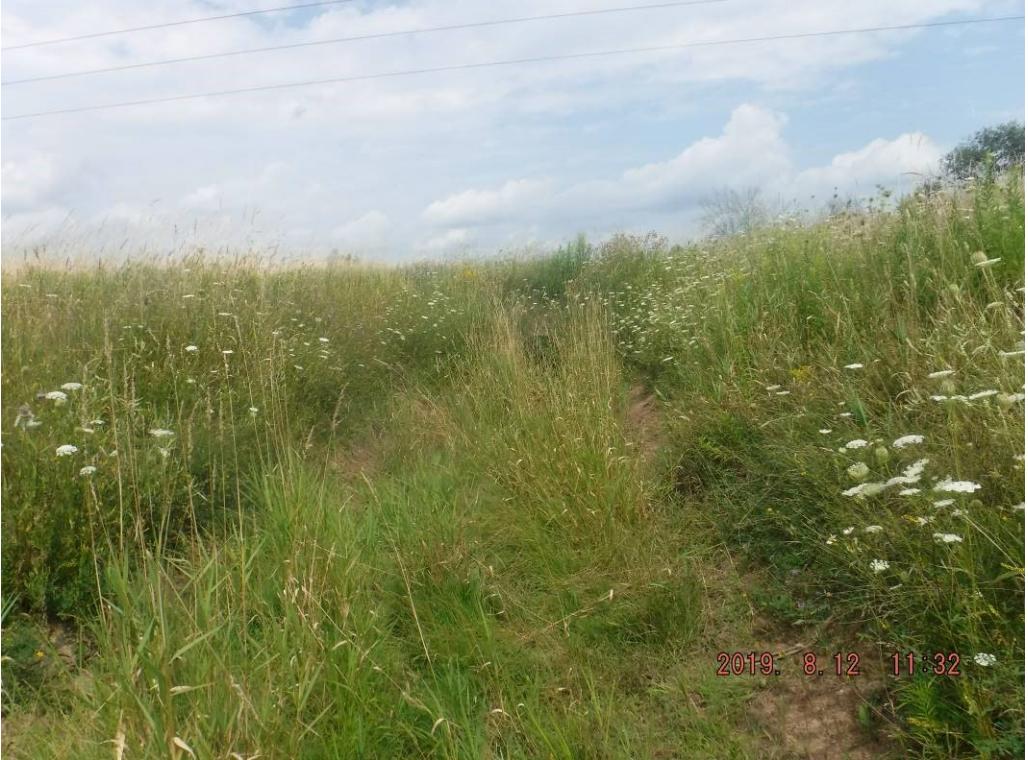
<p><b>Photo No. 49</b></p> <p>Facing North/ Upstream</p> <p><b>Description:</b> Data Point 023 Stream Data Point for perennial Stream 004. Stream 004, an unnamed tributary to Mud Creek.</p>

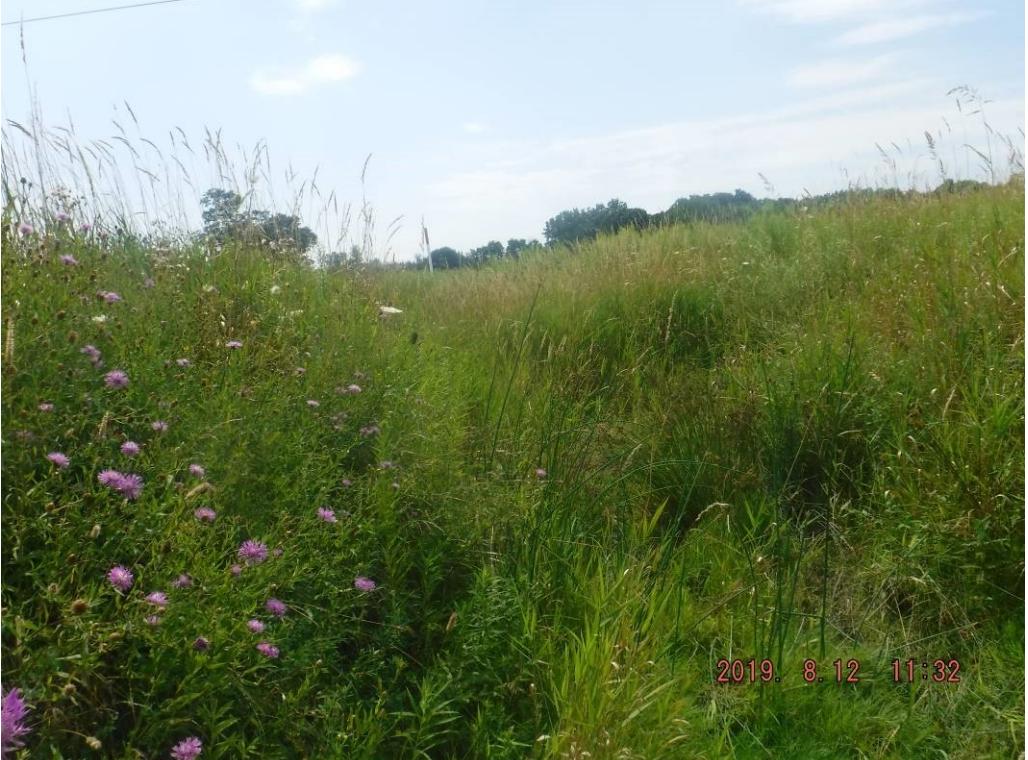
<p><b>Photo No. 50</b></p> <p>Facing South/ Downstream</p> <p><b>Description:</b> Data Point 023 Stream Data Point for perennial Stream 004. Stream 004, an unnamed tributary to Mud Creek.</p>

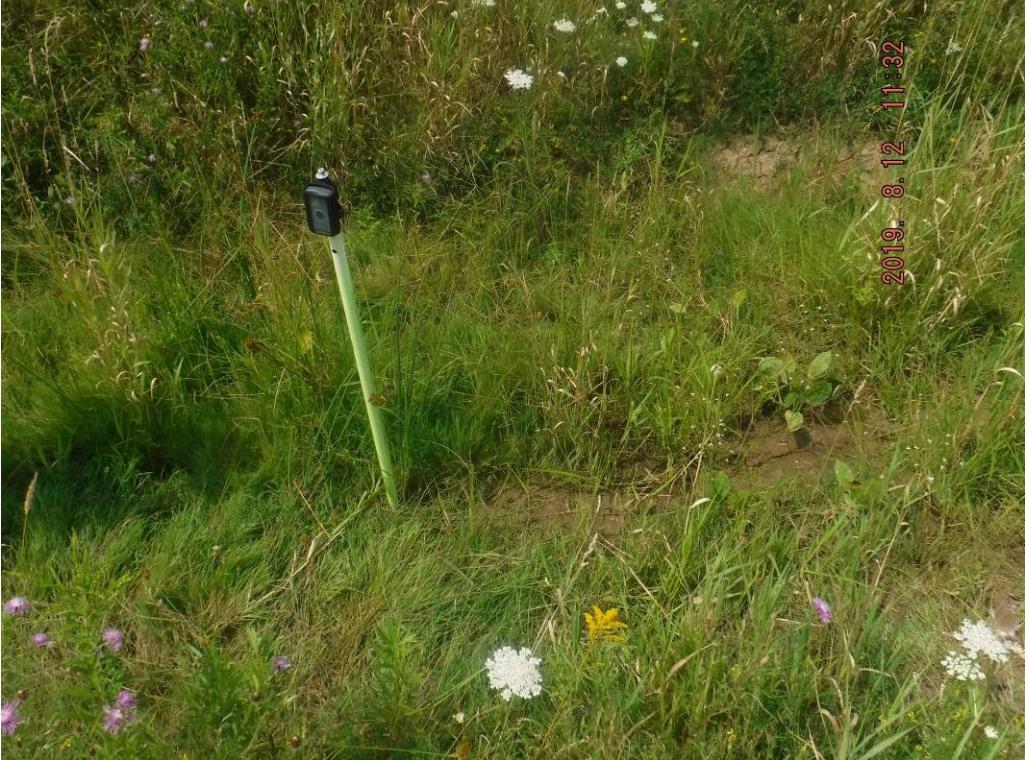
<p><b>Photo No. 51</b></p> <p>Facing West/ Left Bank to Right Bank</p>

<p>2019. 8.12 11:32</p>
<p><b>Description:</b></p> <p>Data Point 023  Stream Data Point for perennial Stream 00. Stream 004, an unnamed tributary to Mud Creek.</p>

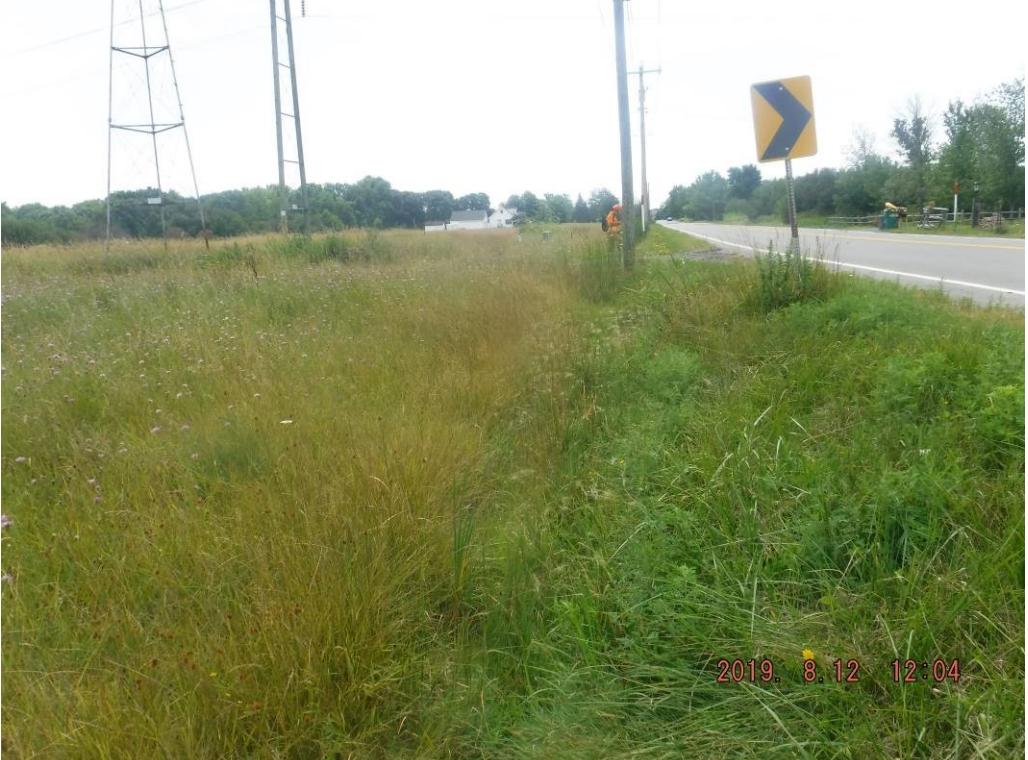
<p><b>Photo No. 52</b></p> <p>Facing South/ Upstream</p>

<p>2019. 8.12 12:04</p>
<p><b>Description:</b></p> <p>Data Point 024  Ditch Data Point for non-jurisdictional ephemeral Ditch 005.</p>

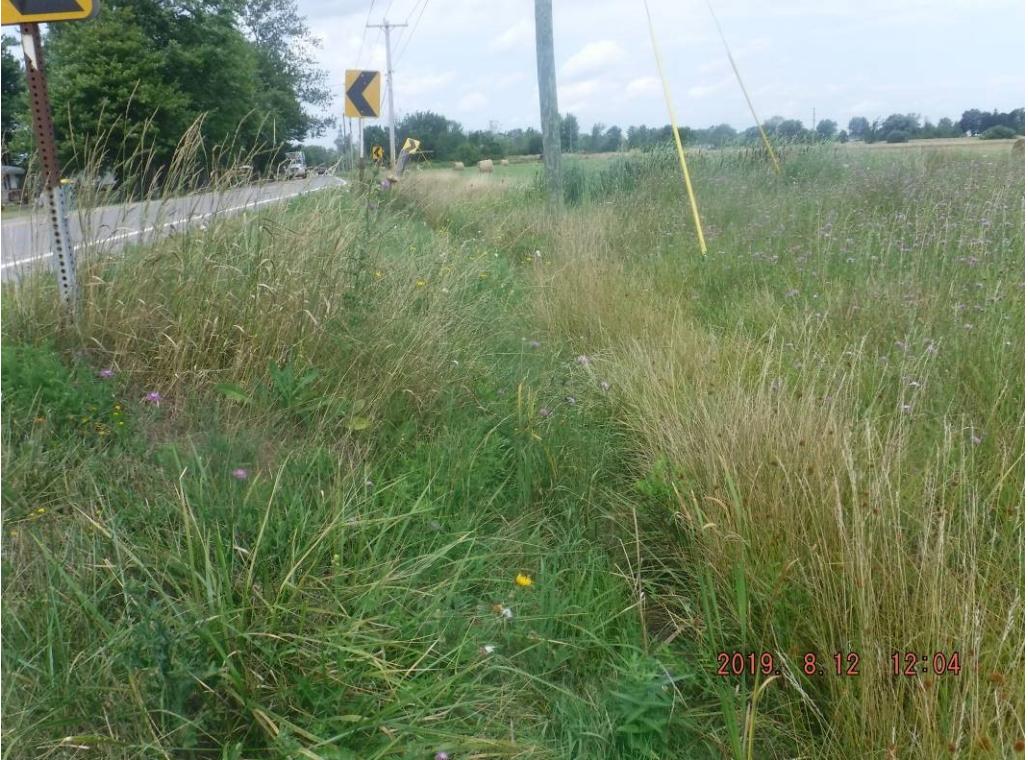
<b>Photo No. 53</b>

<b>Description:</b> Data Point 024 Ditch Data Point for non-jurisdictional ephemeral Ditch 005.

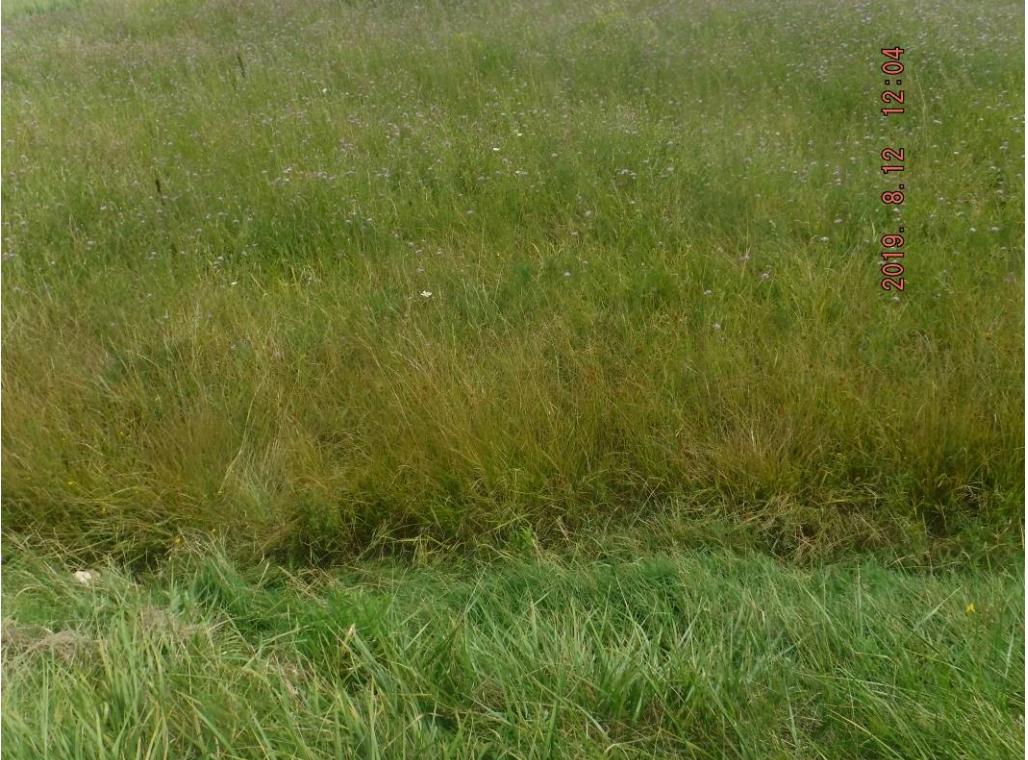
<b>Photo No. 54</b>

<b>Description:</b> Data Point 024 Ditch Data Point for non-jurisdictional ephemeral Ditch 005.

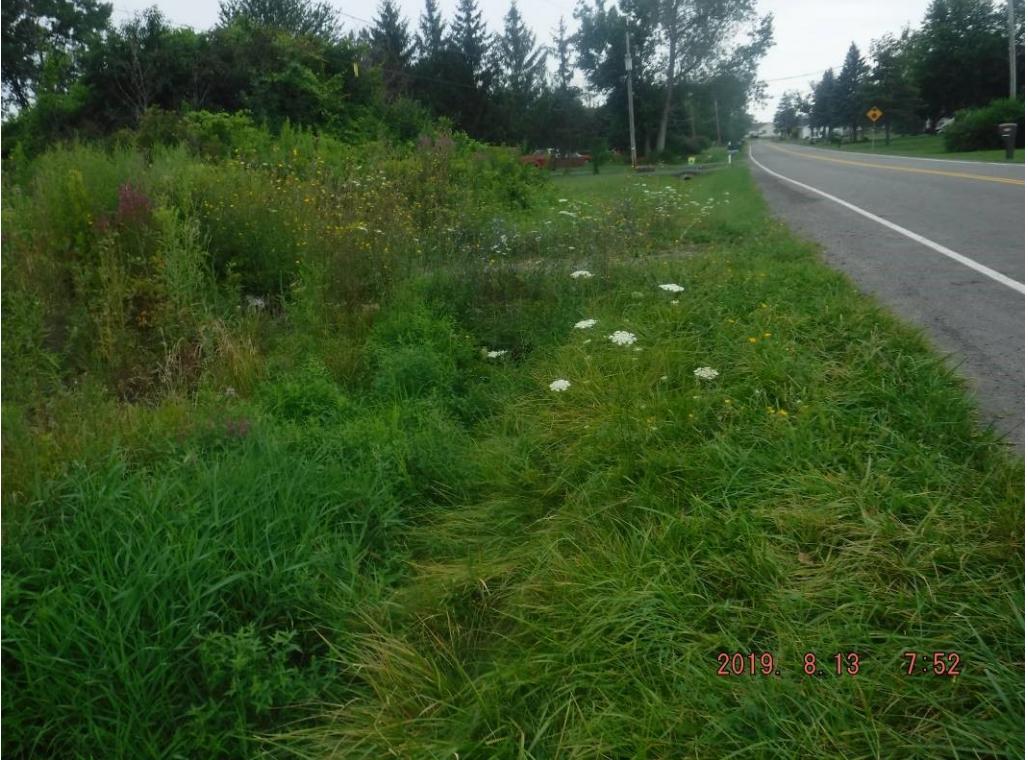
<b>Photo No. 55</b>

<p>2019. 8. 13 7:52</p>
<p>Facing North/ Upstream</p> <p><b>Description:</b> Data Point 025 Ditch Data Point for non-jurisdictional ephemeral Ditch 006.</p>

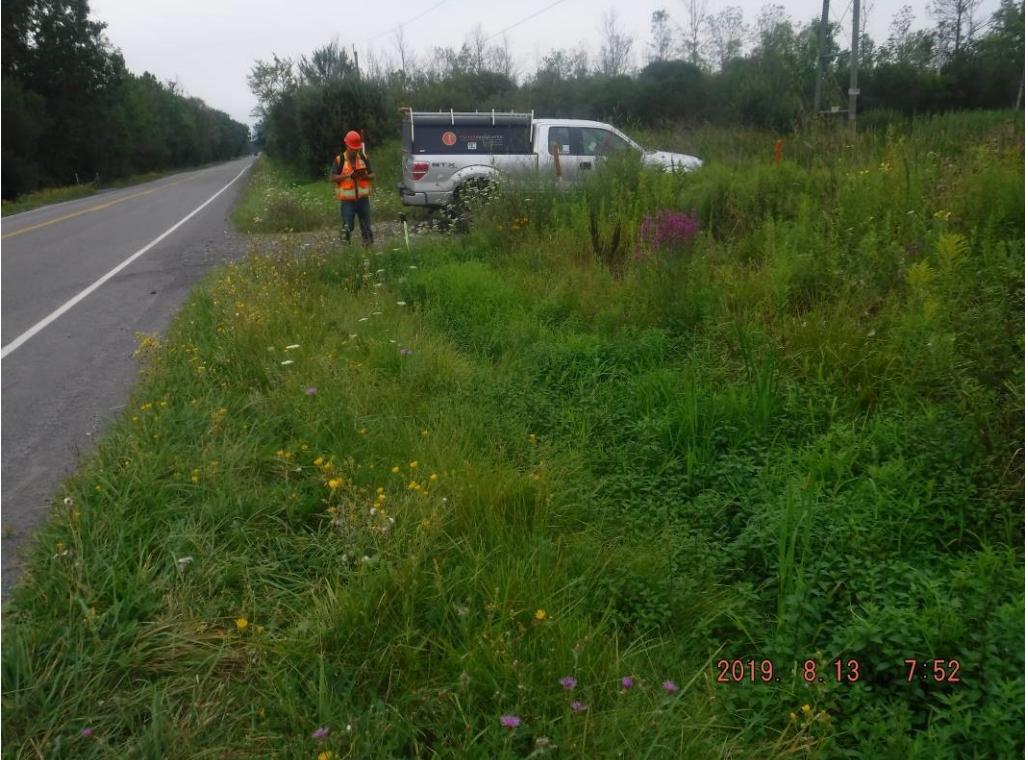
<b>Photo No. 56</b>

<p>2019. 8. 13 7:52</p>
<p>Facing South/ Downstream</p> <p><b>Description:</b> Data Point 025 Ditch Data Point for non-jurisdictional ephemeral Ditch 006.</p>
