## **Lockport-Batavia Line #112 Rebuild Project**

### **EM&CP Update**

### **Replacement Appendix G (SWPPP)**

*(Revised January 2026; Replaces Version Filed June 2025)*

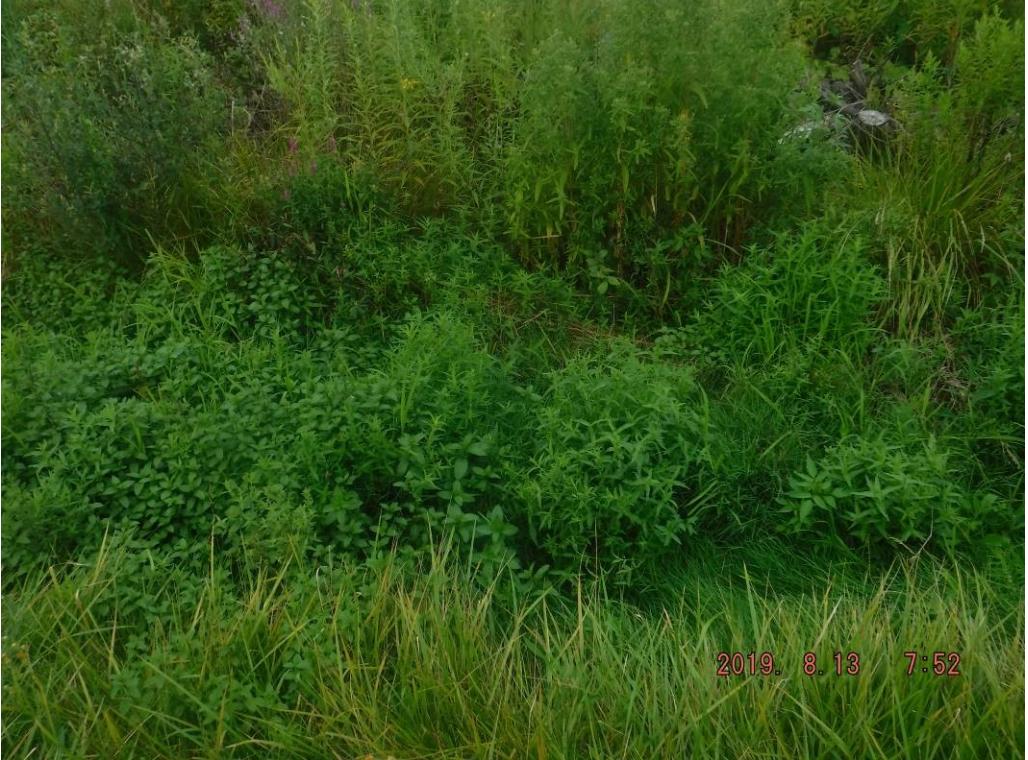
<b>Photo No. 57</b>

<p>2019. 8.13 7:52</p>
<b>Description:</b> Data Point 025  Ditch Data Point for non-jurisdictional ephemeral Ditch 006.

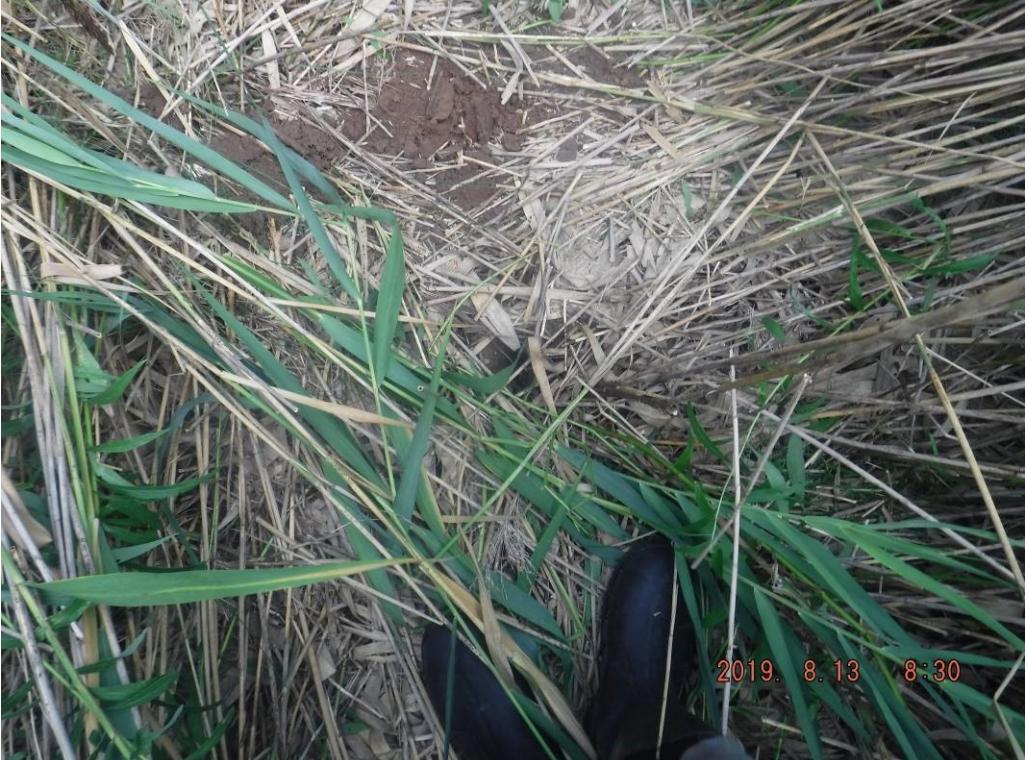
<b>Photo No. 58</b>

<p>2019. 8.13 8:30</p>
<b>Description:</b> Data Point 026  PEM Data Point for Wetland 009.

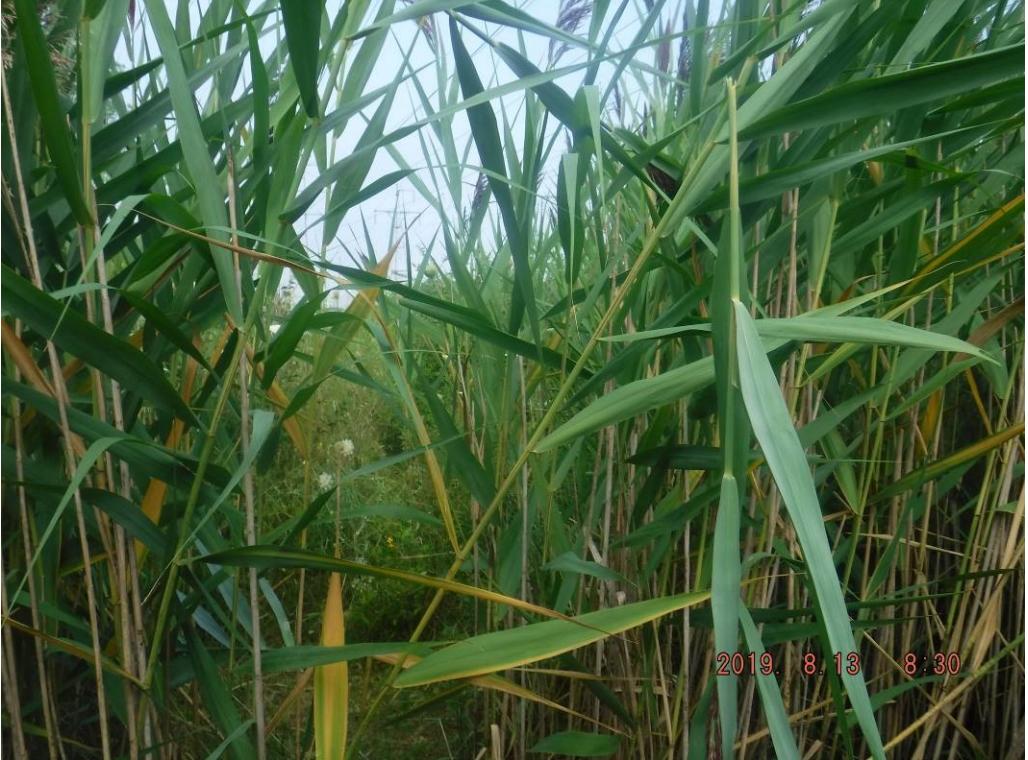
<b>Photo No. 59</b>

Facing North  <b>Description:</b> Data Point 026 Overview of PEM Wetland 009.

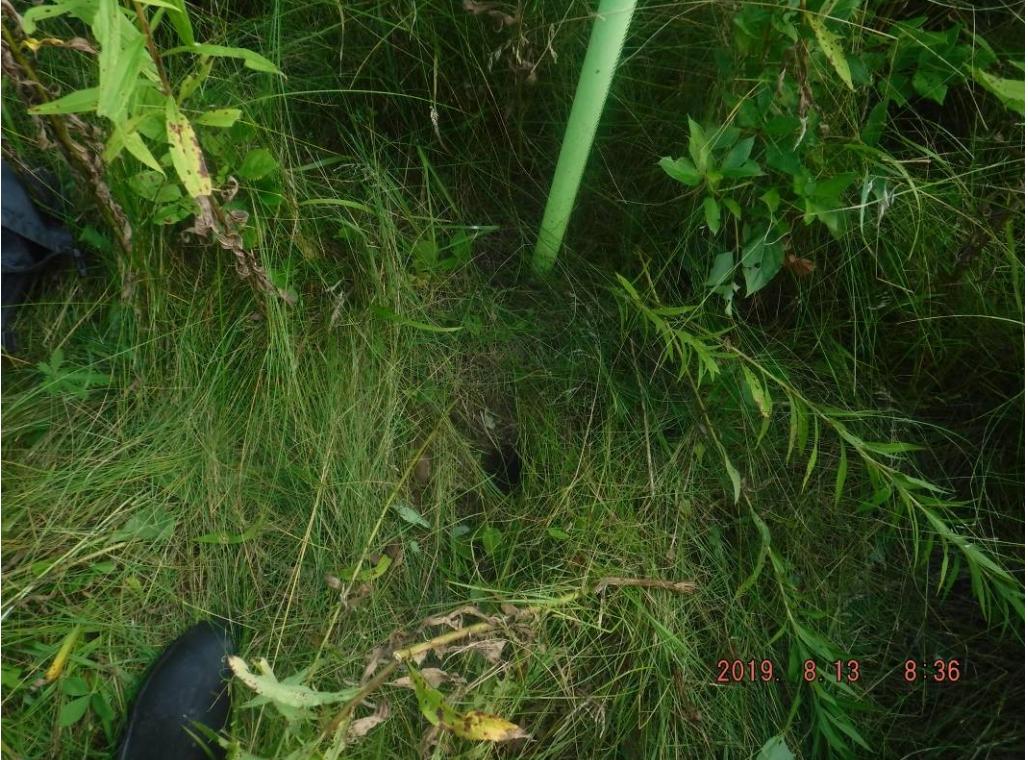
<b>Photo No. 60</b>

Facing North  <b>Description:</b> Data Point 027 Data Point for upland/dryland adjacent to Wetland 009.

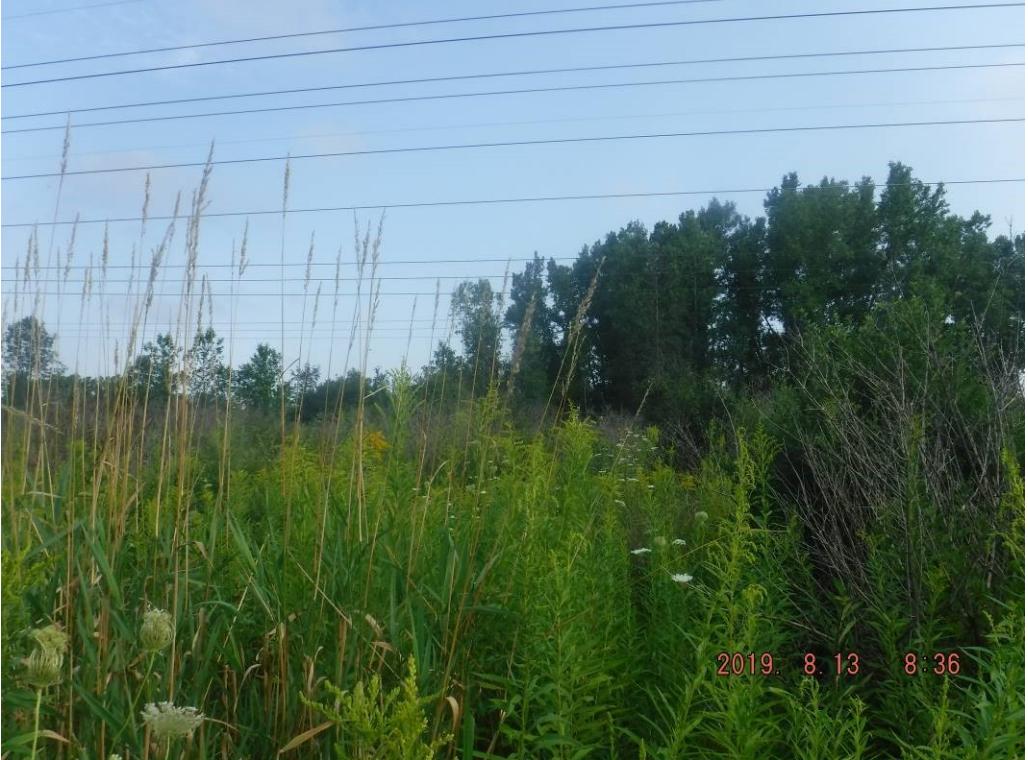
<b>Photo No. 61</b>

<p>2019. 8. 13 8:36</p>
<p>Facing North</p> <p><b>Description:</b> Data Point 027 Data Point for upland/dryland adjacent to Wetland 009.</p>

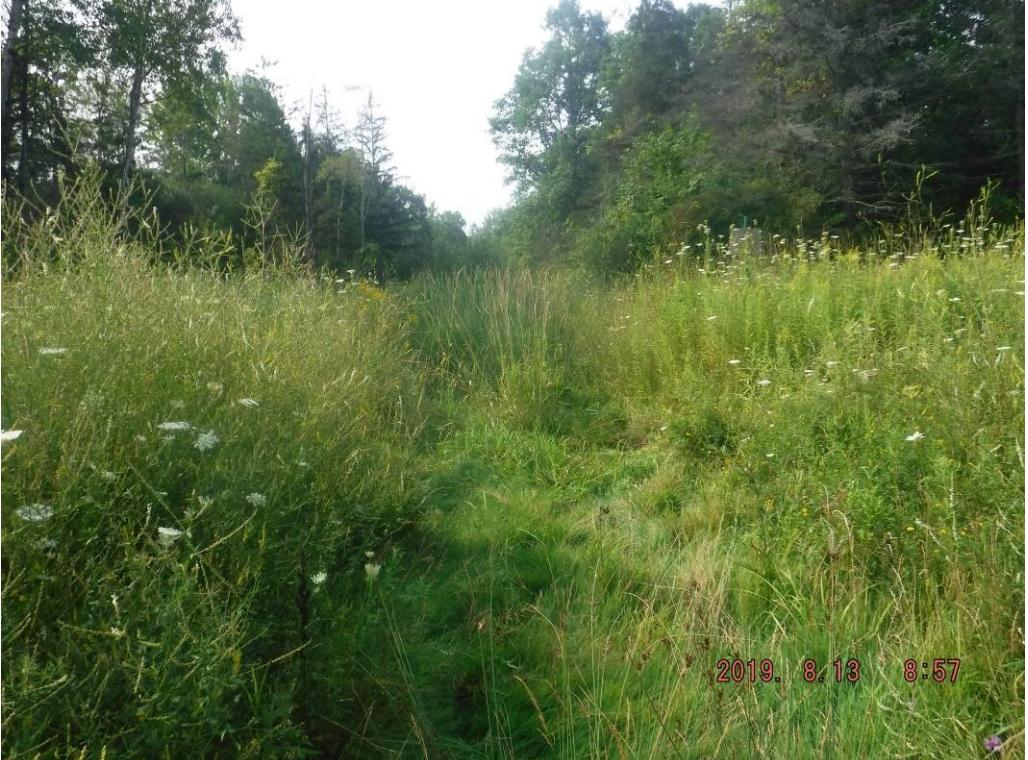
<b>Photo No. 62</b>

<p>2019. 8. 13 8:57</p>
<p>Facing South/ Upstream</p> <p><b>Description:</b> Data Point 028 Stream Data Point for intermittent Stream 005. Stream 005, an unnamed tributary to Mud Creek.</p>

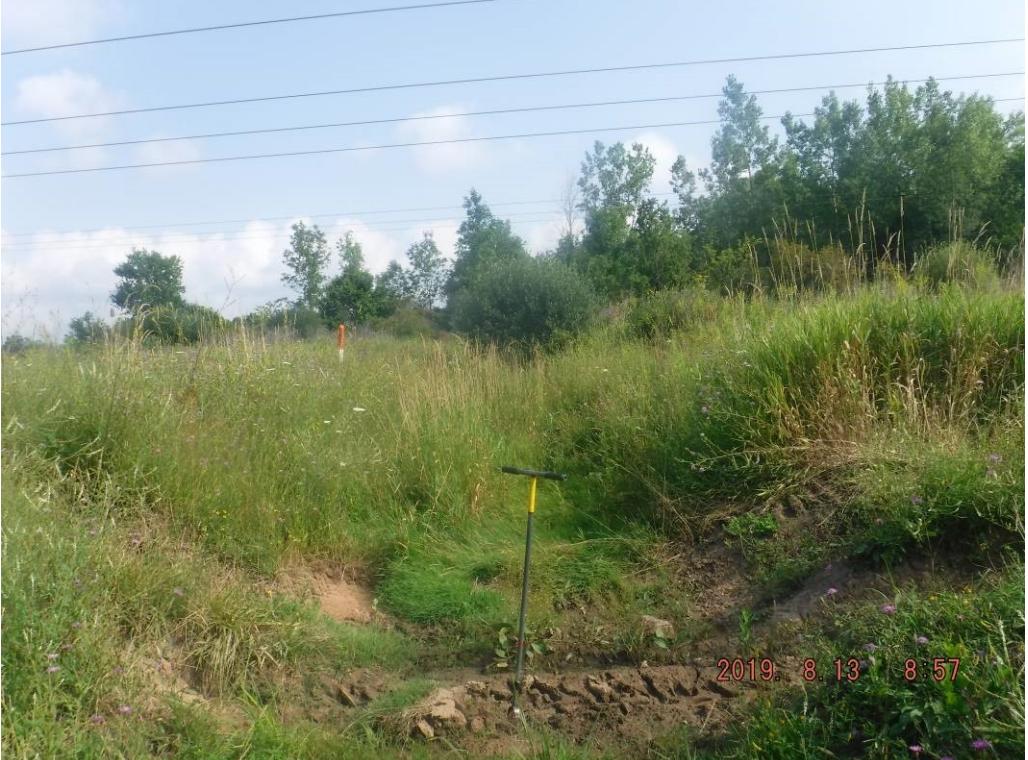
<b>Photo No. 63</b>

<p>Facing North/ Downstream</p> <p><b>Description:</b> Data Point 028 Stream Data Point for intermittent Stream 005. Stream 005, an unnamed tributary to Mud Creek.</p>

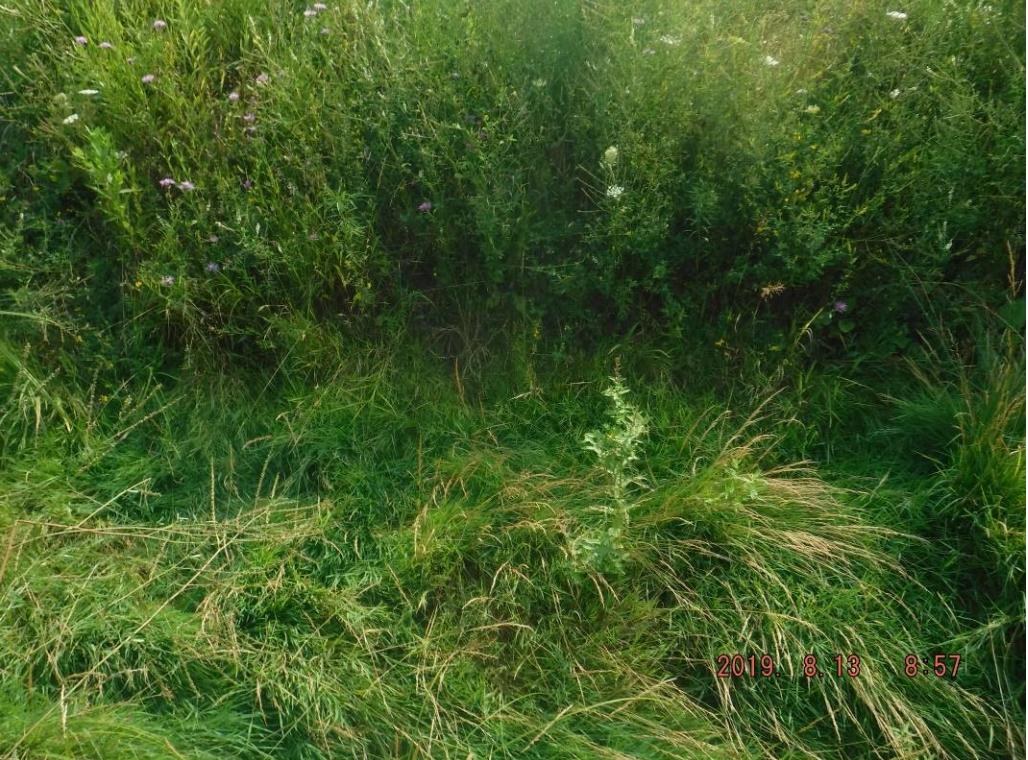
<b>Photo No. 64</b>

<p>Facing East/ Left Bank to Right Bank</p> <p><b>Description:</b> Data Point 028 Stream Data Point for intermittent Stream 005. Stream 005, an unnamed tributary to Mud Creek.</p>

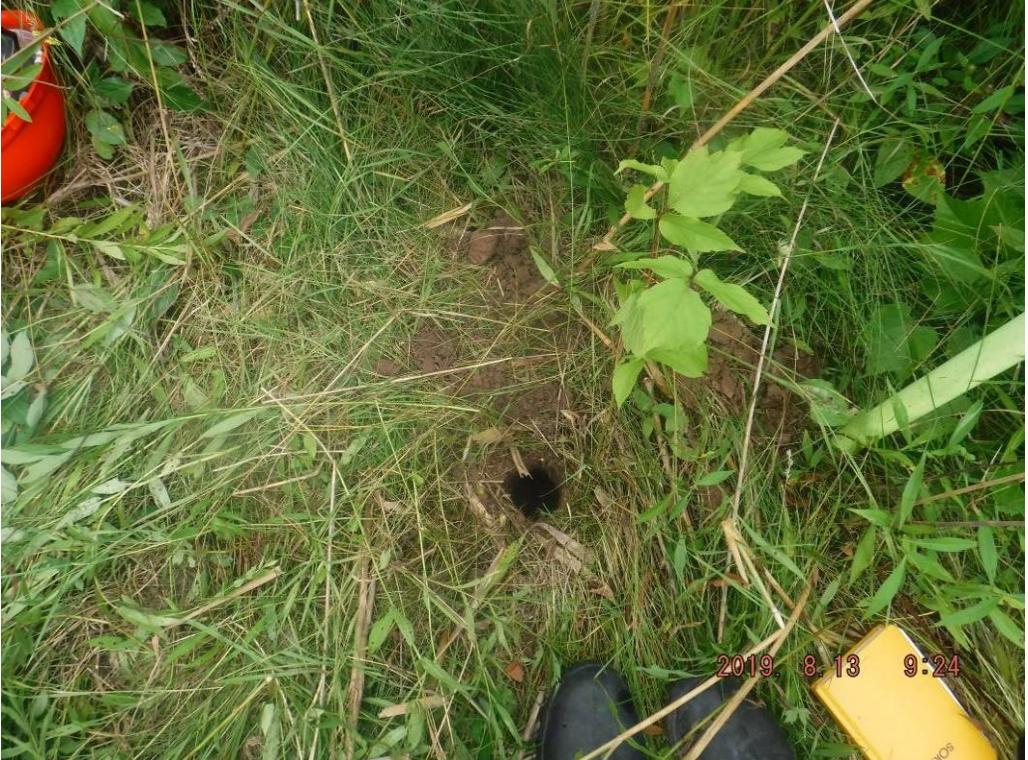
<p><b>Photo No. 65</b></p> <p>Facing North</p> <p><b>Description:</b> Data Point 029 PEM Data Point for Wetland 010.</p>

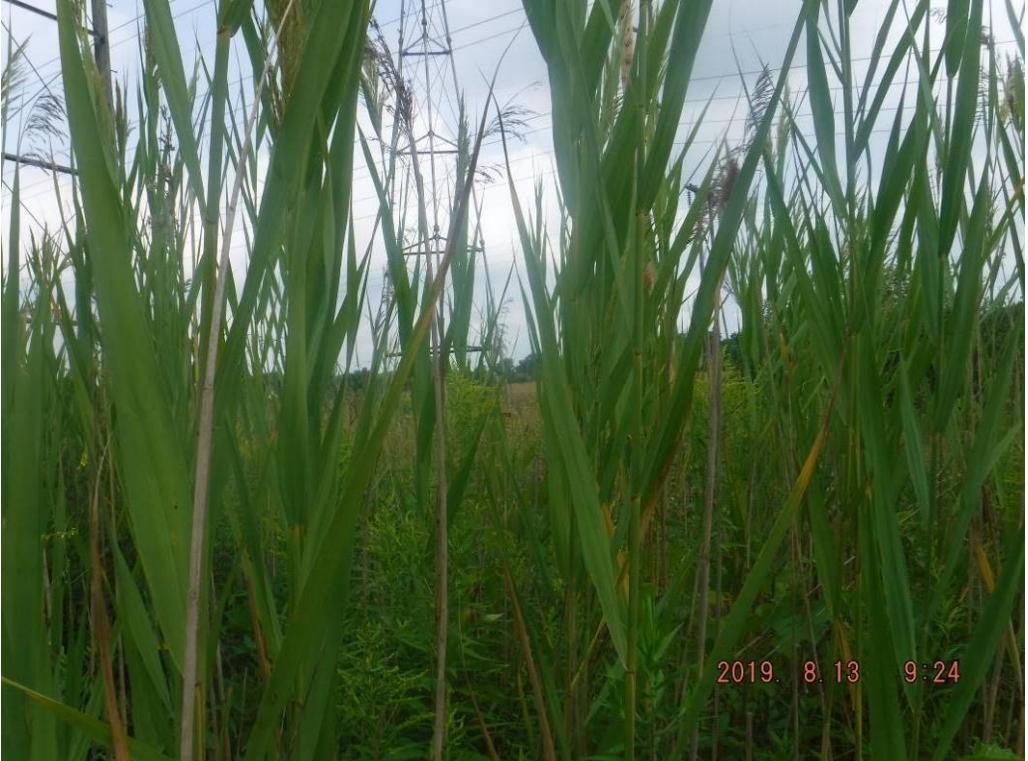
<p><b>Photo No. 66</b></p> <p>Facing North</p> <p><b>Description:</b> Data Point 029 Overview of PEM Wetland 010.</p>

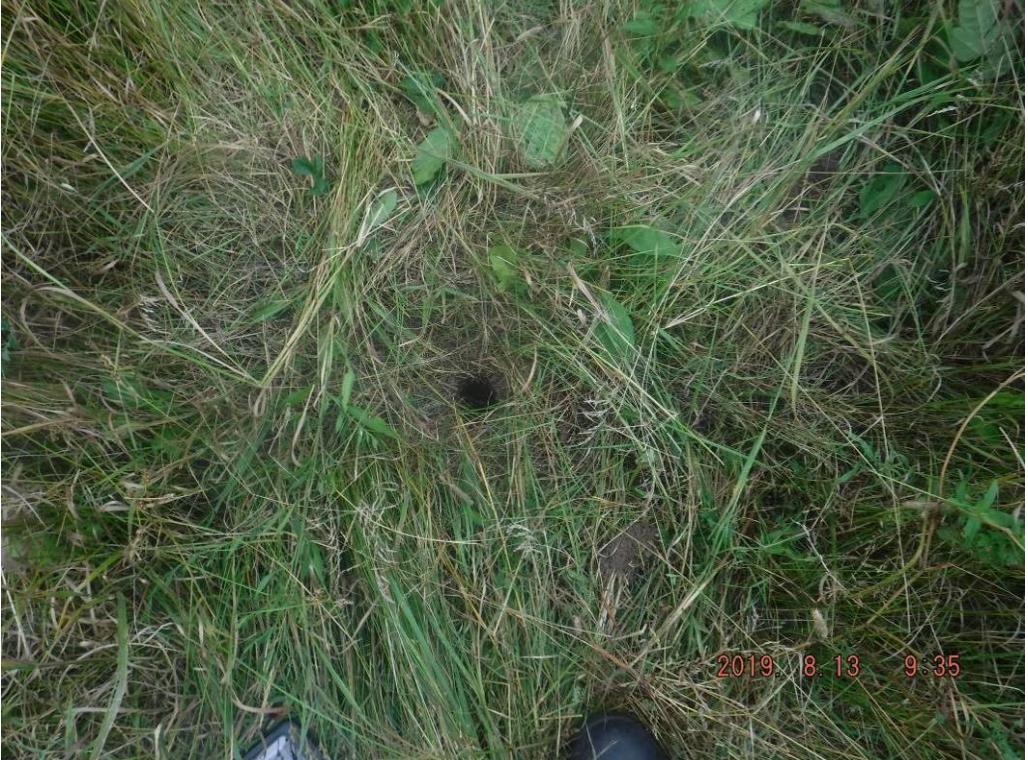
<b>Photo No. 67</b>

Facing North

<b>Description:</b>	
<p>Data Point 030 Data Point for upland/dryland adjacent to Wetland 010.</p>

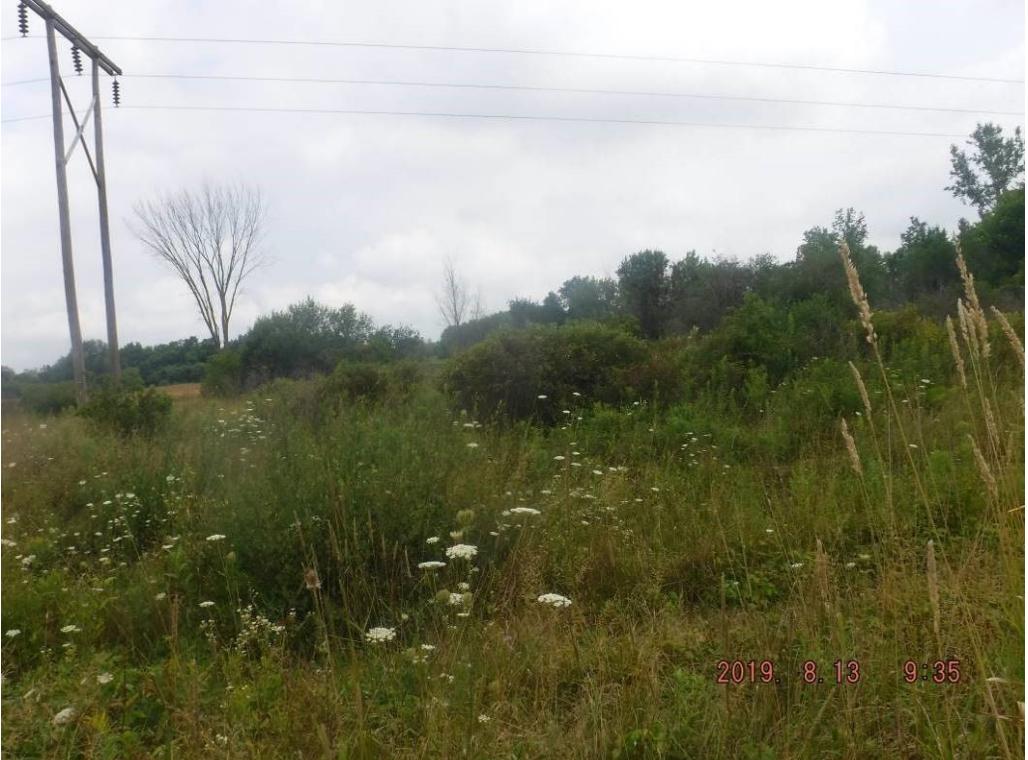
<b>Photo No. 68</b>

Facing North

<b>Description:</b>	
<p>Data Point 030 Overview of upland/dryland adjacent to Wetland 010.</p>

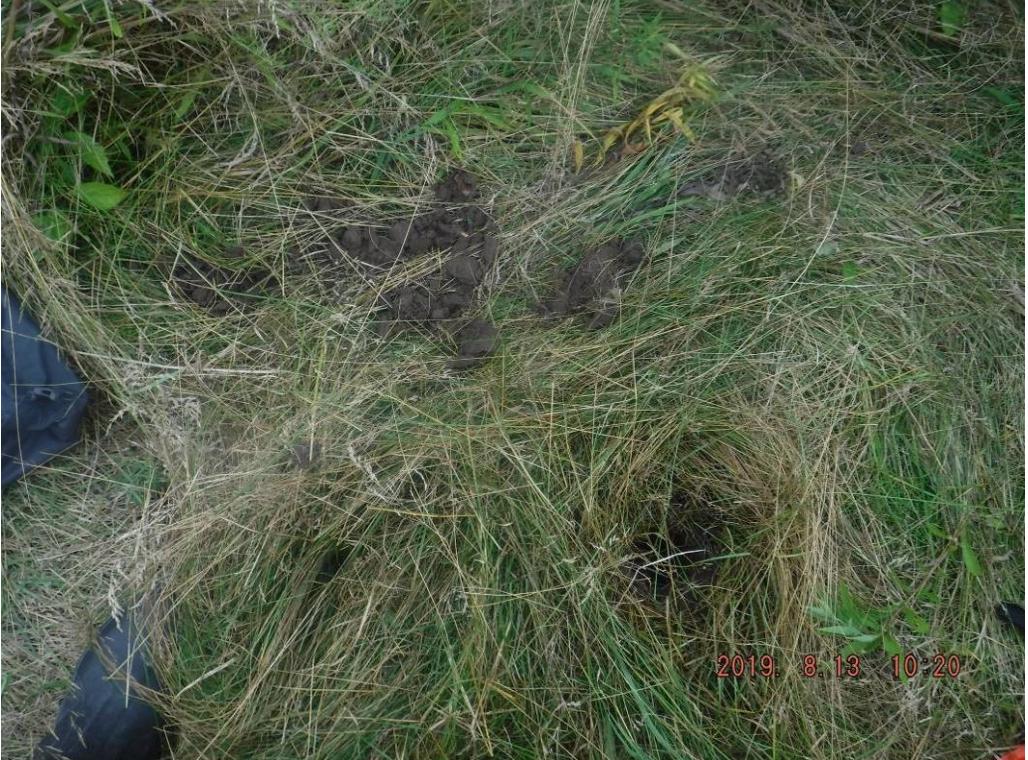
<b>Photo No. 69</b>

<p>2019. 8.13 10:20</p>
<p>Facing North</p> <p><b>Description:</b></p> <p>Data Point 031 Data Point for upland/dryland adjacent to Wetland 011.</p>

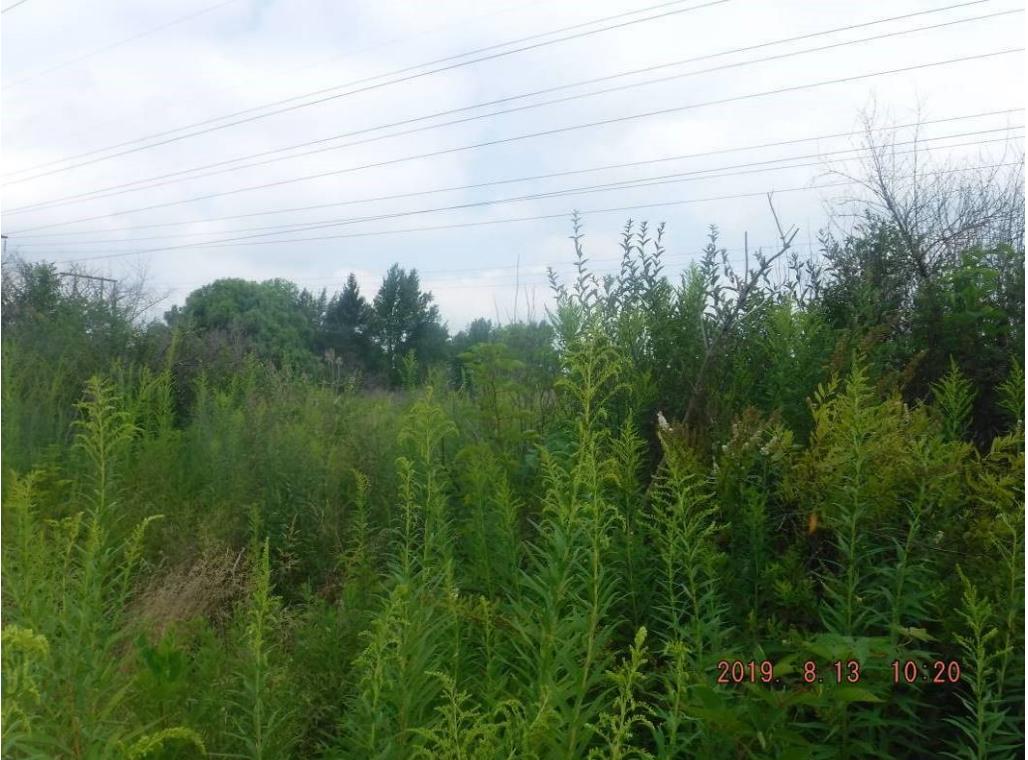
<b>Photo No. 70</b>

<p>2019. 8.13 10:20</p>
<p>Facing North</p> <p><b>Description:</b></p> <p>Data Point 031 Overview of upland/dryland adjacent to Wetland 011.</p>

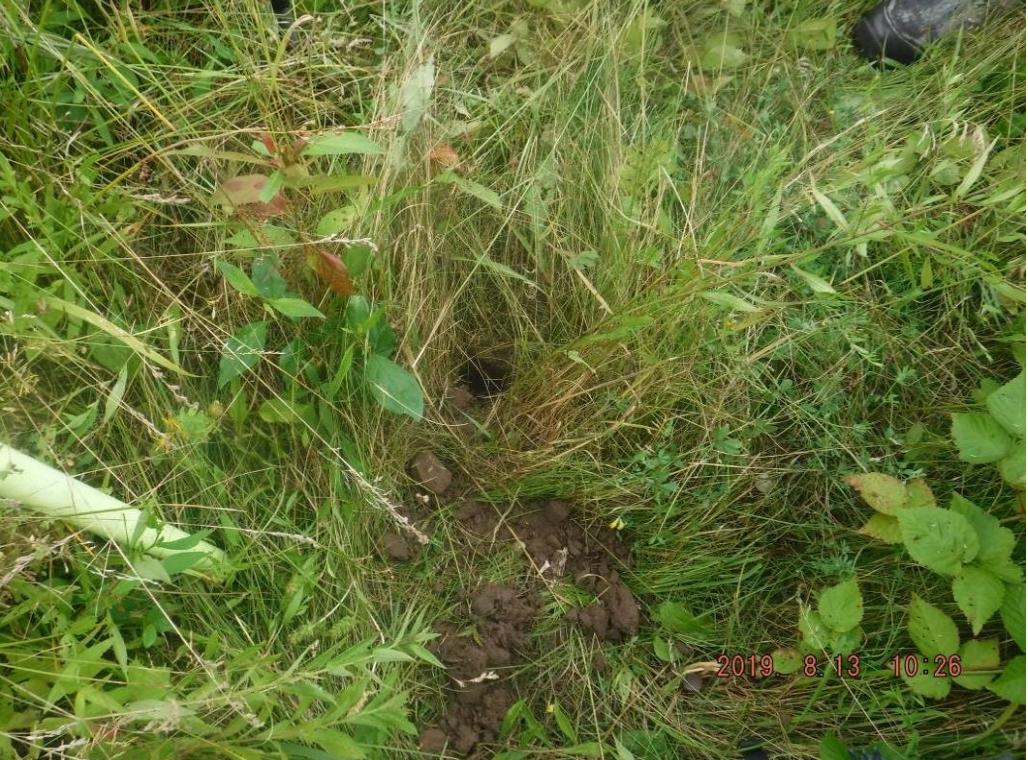
<b>Photo No. 71</b>

<p>Facing North</p> <p><b>Description:</b> Data Point 032 PEM Data Point for Wetland 011.</p>

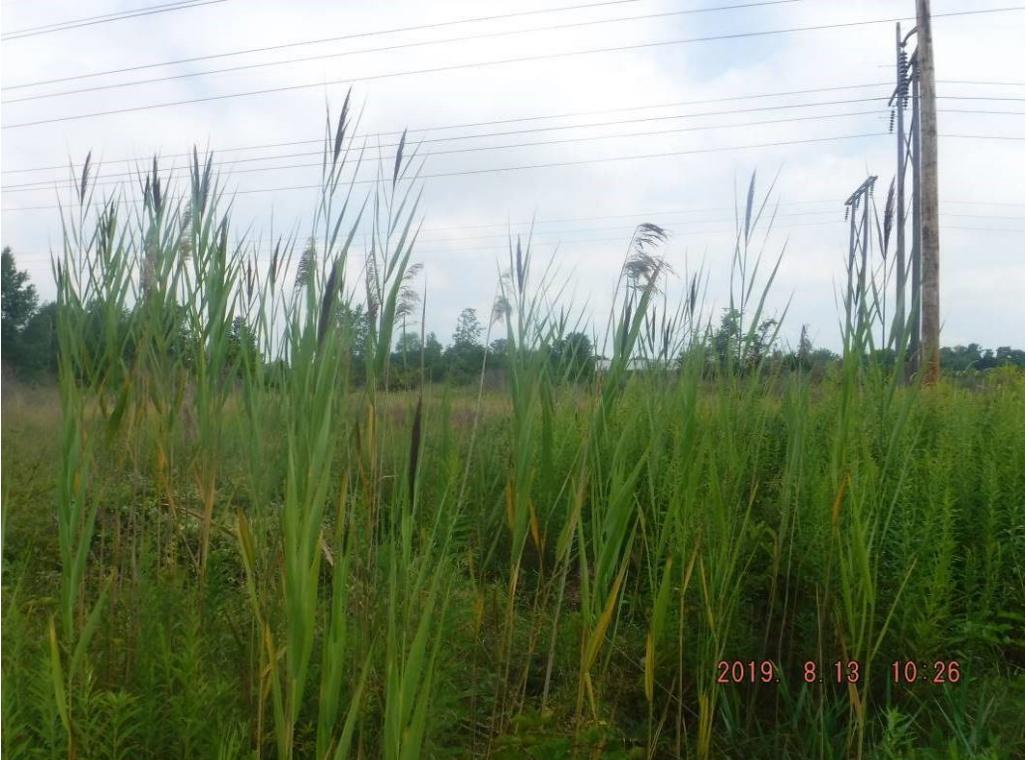
<b>Photo No. 72</b>

<p>Facing North</p> <p><b>Description:</b> Data Point 032 Overview of PEM Wetland 011.</p>

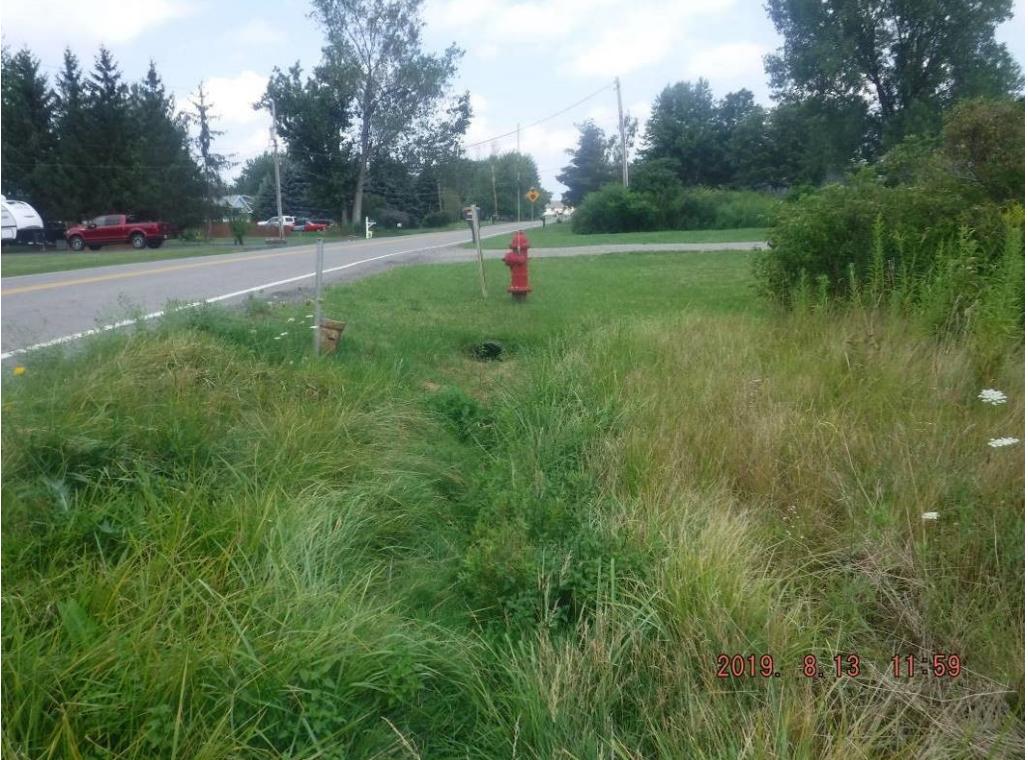
<p><b>Photo No. 73</b></p> <p>Facing North/ Upstream</p>

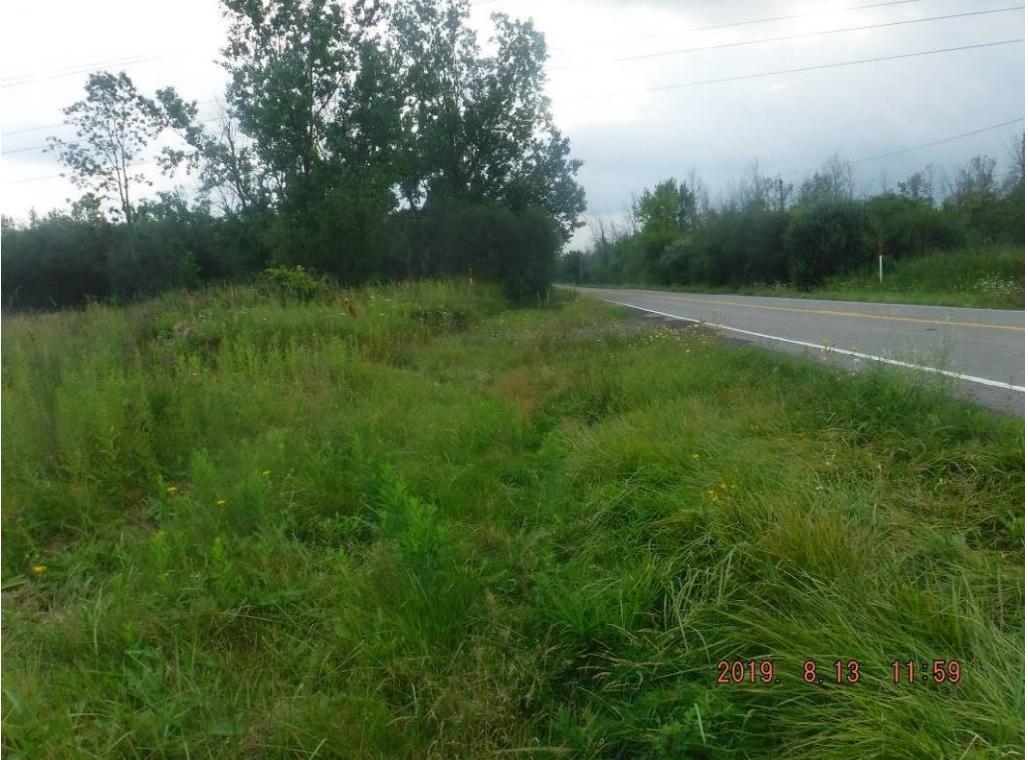
<p><b>Photo No. 74</b></p> <p>Facing South/ Downstream</p>

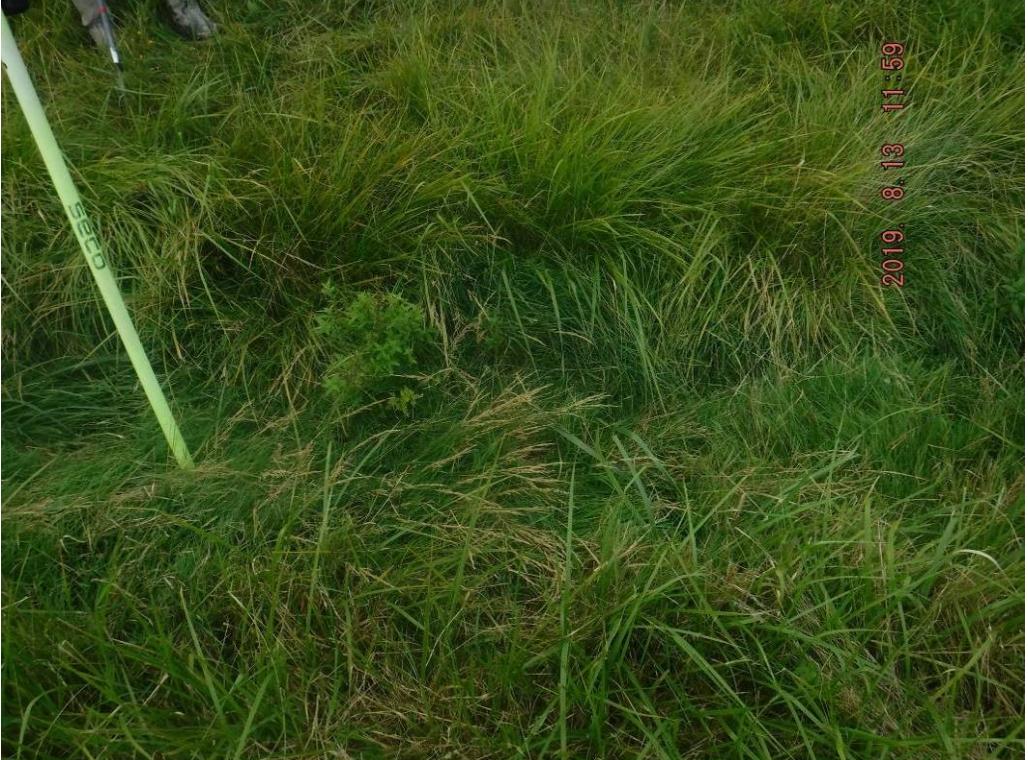
<p><b>Photo No. 75</b></p> <p>Facing West/ Left Bank to Right Bank</p> <p><b>Description:</b> Data Point 033 Ditch Data Point for non-jurisdictional ephemeral Ditch 007.</p>

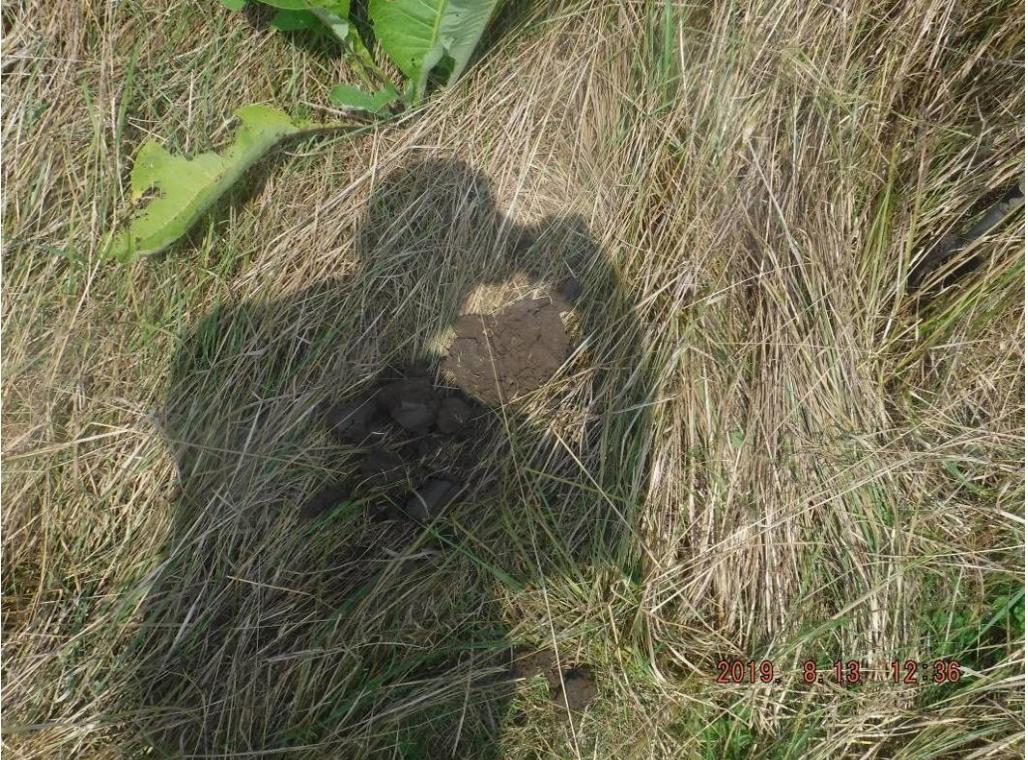
<p><b>Photo No. 76</b></p> <p>Facing North</p> <p><b>Description:</b> Data Point 034 Data Point for upland/dryland adjacent to Wetland 012.</p>
